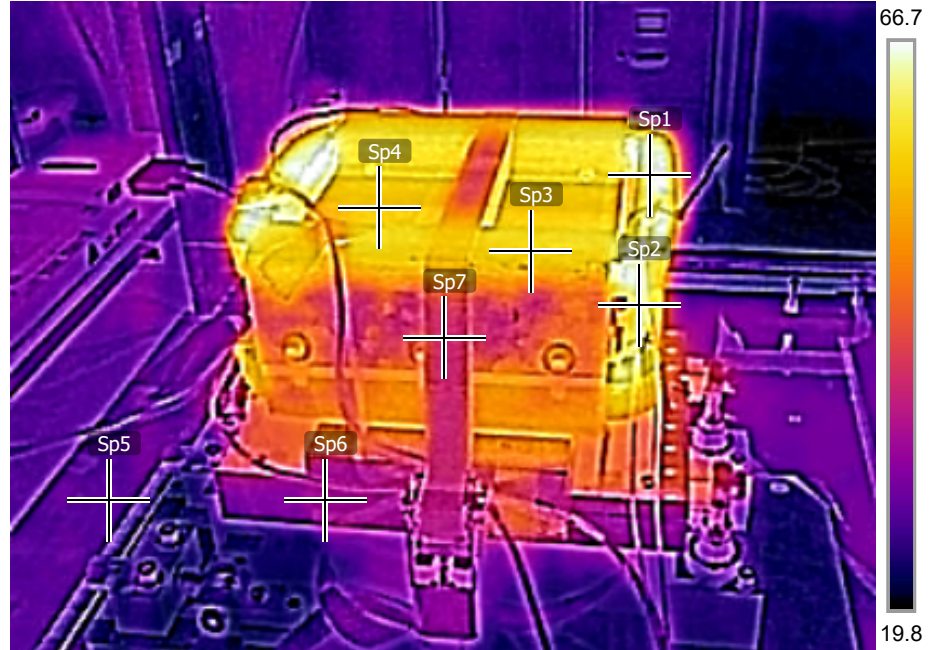
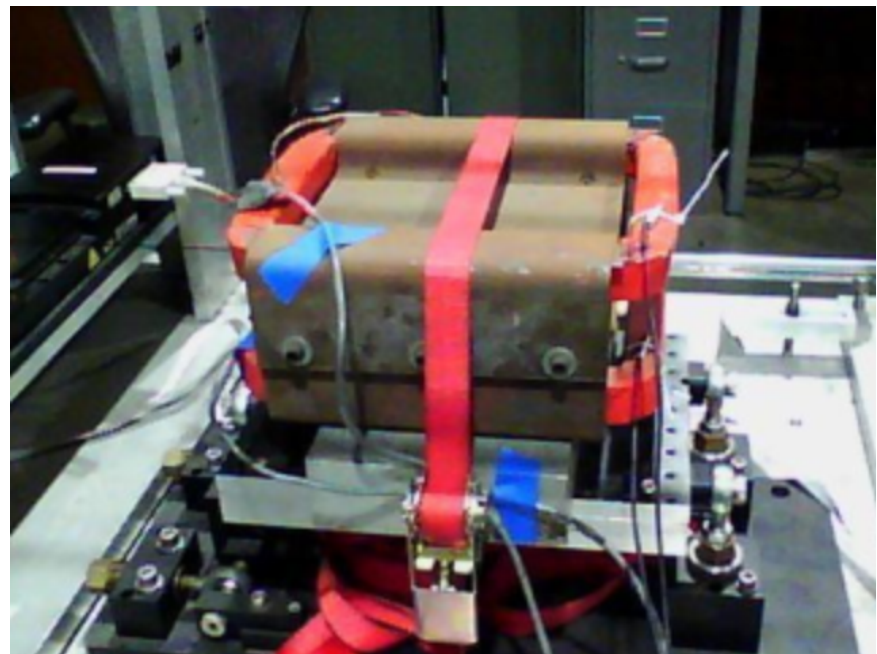
FLIR0022.jpg

This is a type 4 corrector just after the current was ramped down because the top coil reached 68 deg C.

Sp1	64.0 °C
Sp2	61.4 °C
Sp3	54.6 °C
Sp4	53.0 °C
Sp5	24.5 °C
Sp6	27.6 °C
Sp7	33.4 °C

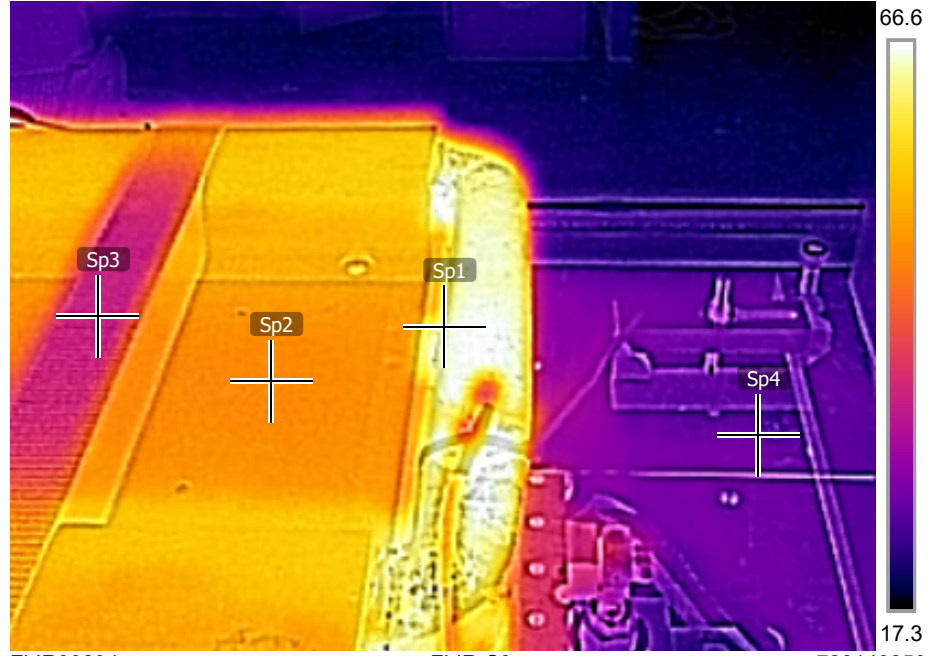
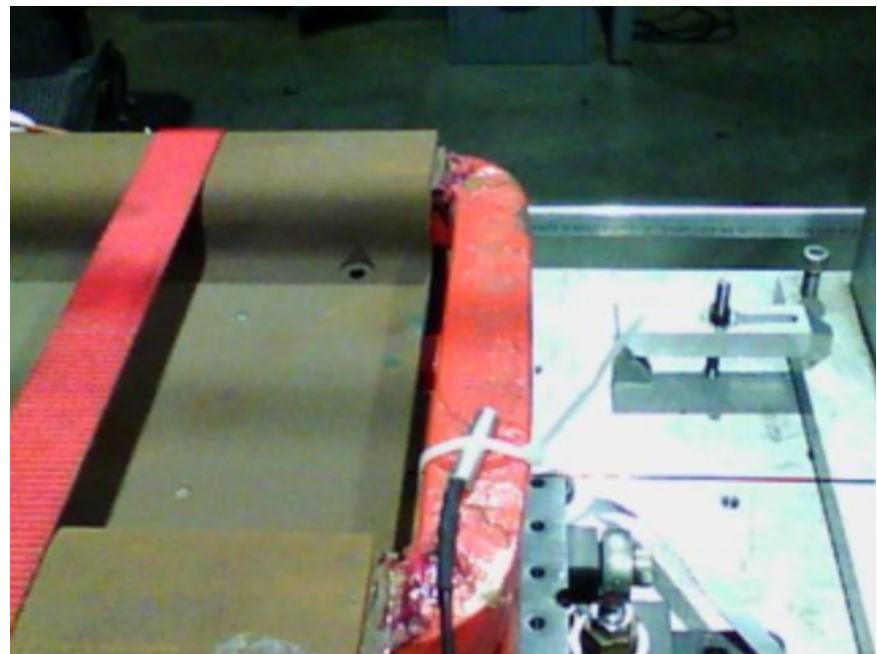
FLIR0023.jpg

This is a type 4 corrector just after the current was ramped down because the top coil reached 68 deg C.

Sp1	64.2 °C
Sp2	51.2 °C
Sp3	34.7 °C
Sp4	23.2 °C

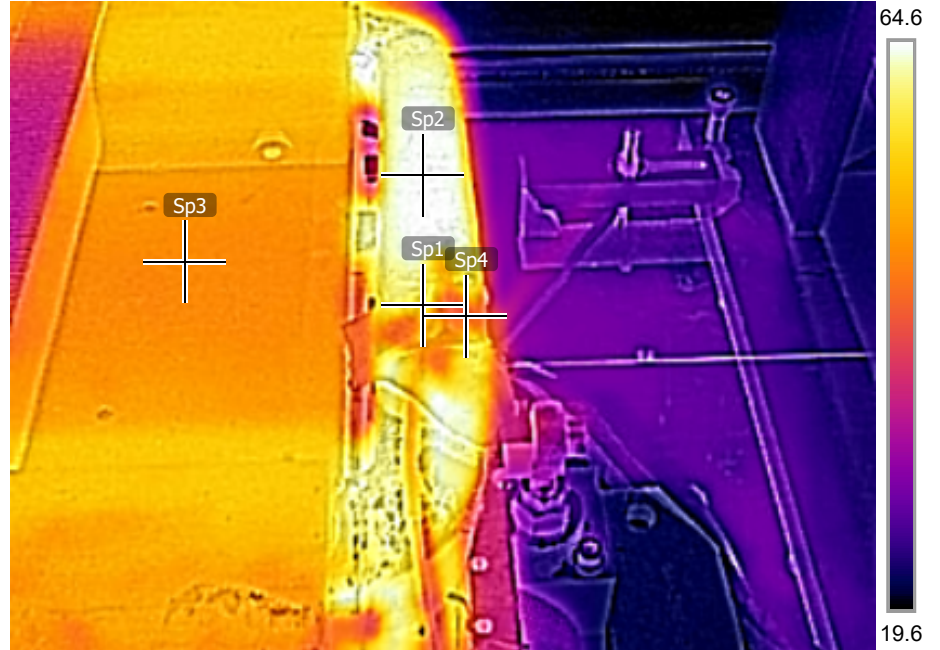
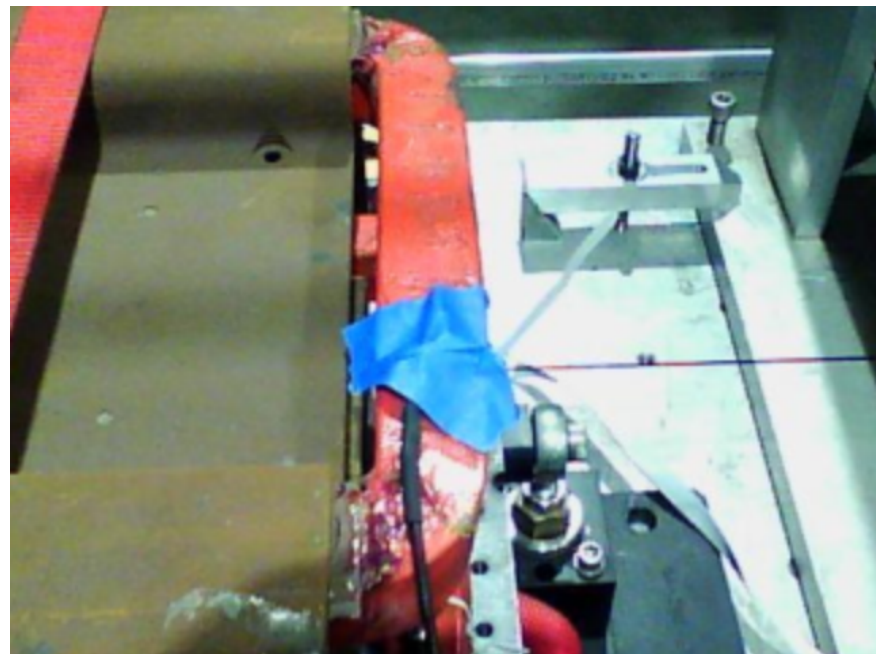
FLIR0024.jpg

This is a type 4 corrector just after the current was ramped down because the top coil reached 68 deg C.

Sp1	56.4 °C
Sp2	64.7 °C
Sp3	51.6 °C
Sp4	48.6 °C
