MFD NON-COMPLIANCE REPORT # 30121-1

PART NAME: **HXU PROTO INTERSPACE PL**
PF/SA NO.: **SA-389-893-00 R1**
WORK ORDER NO.: **30121-1 (8924593)**
VENDOR **MFD**

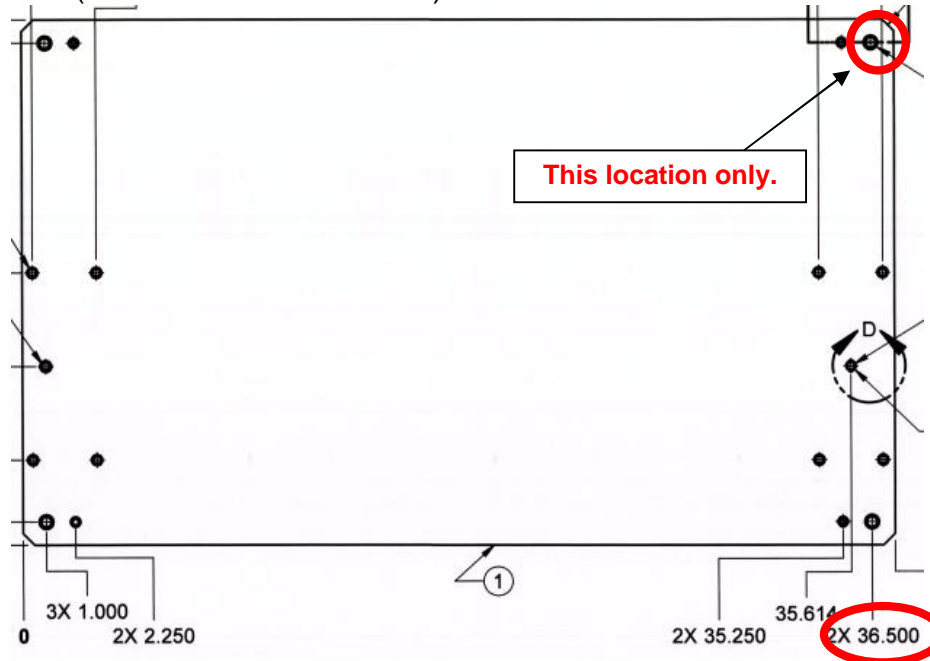
1. Distance of Helicoil $\frac{1}{2}$ -13 (STI Thread) 2X 36.500 \pm 0.005" is out of tolerance on 1 of 2 holes measuring 36.4906 (-0.0044" out of tolerance). See below for location and for clarity.
