MFD NON-COMPLIANCE REPORT # 31066-3

PART NAME: **Vacuum Chamber Assy**
PF/SA NO.: **SC-391-264-04 R1**
WORK ORDER NO.: **31066-3**
VENDOR **Nor Cal**

DATE: **6/26/14**
INSPECTOR: **K. Caban**
ENGINEER: **J. DeLor** EXT.: **3136**
ROUTE TO: **Mtlfnsh**

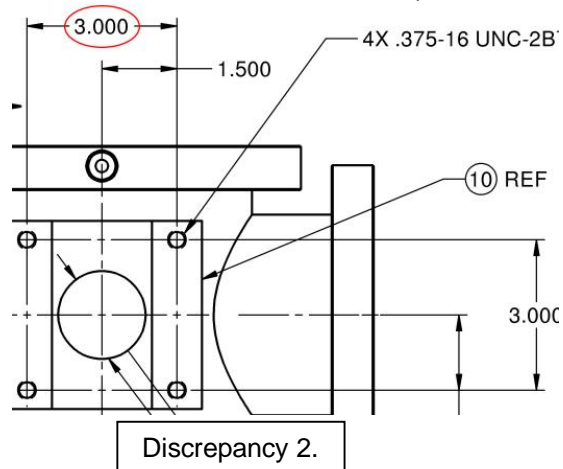
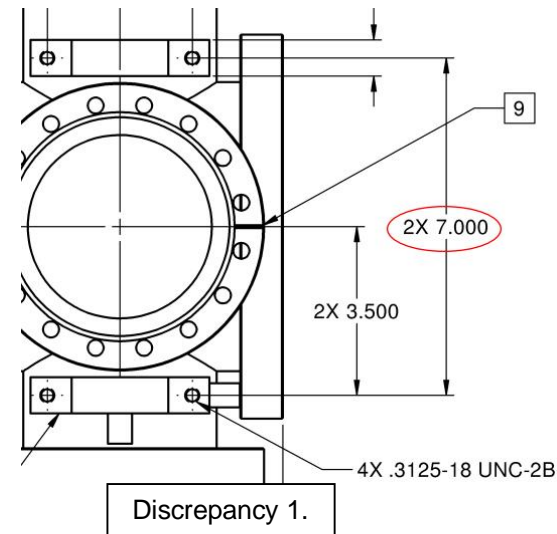
1. 2X 7.000 ± 0.005 of 5/16-18 UNC-2B Threaded Holes measure 6.9670 (-0.028" out of tolerance).
 - a. 5/16-18 UNC-2B Threaded Holes had to be chased (Thread Burrs). Ok now.
2. Distance 3.000 ± 0.005 of 3/8-16 UNC-2B Threaded Holes measured 3.0135 (+0.0085" out of tolerance).
