2/27/2008

Recent Safety Concern from the SLAC Alignment Engineering Group

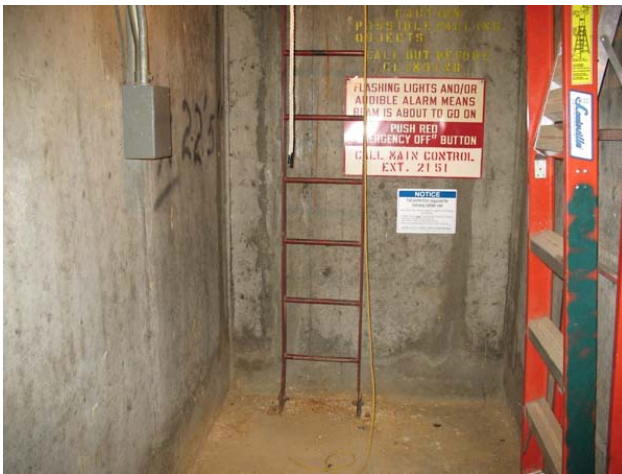
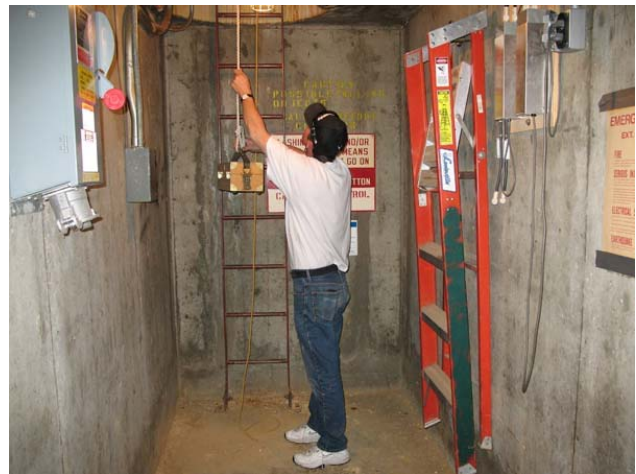
Recently the alignment group was asked to verify the position of the linac's 28-801 quad. This involves equipment being lowered into the linac by means of one of the manways located at every sector. Upon arriving at the sector 28 penetration the team noticed the rope used to lower equipment to the housing floor of the linac was not long enough to safely accomplish the task. Below are pictures showing the concerns of the group.

Due to the short length of the rope the load must be held up and balanced as it is tied or untied to the rope. This increases the risk of injury to the back and also the risk of objects falling after being unattached from the rope. The increased risk of injury could be avoided if the rope was able to come into contact with the floor of the housing plus a couple of feet with a load attached.

Follow up 3/04/2008: Talked with Al Baker and was told the rope had been fixed.
