Sector 2 – Alignment of LI02 QUAD 991
July 27, 2005 ROD AEG Report

Status Summary of July 20, 2005

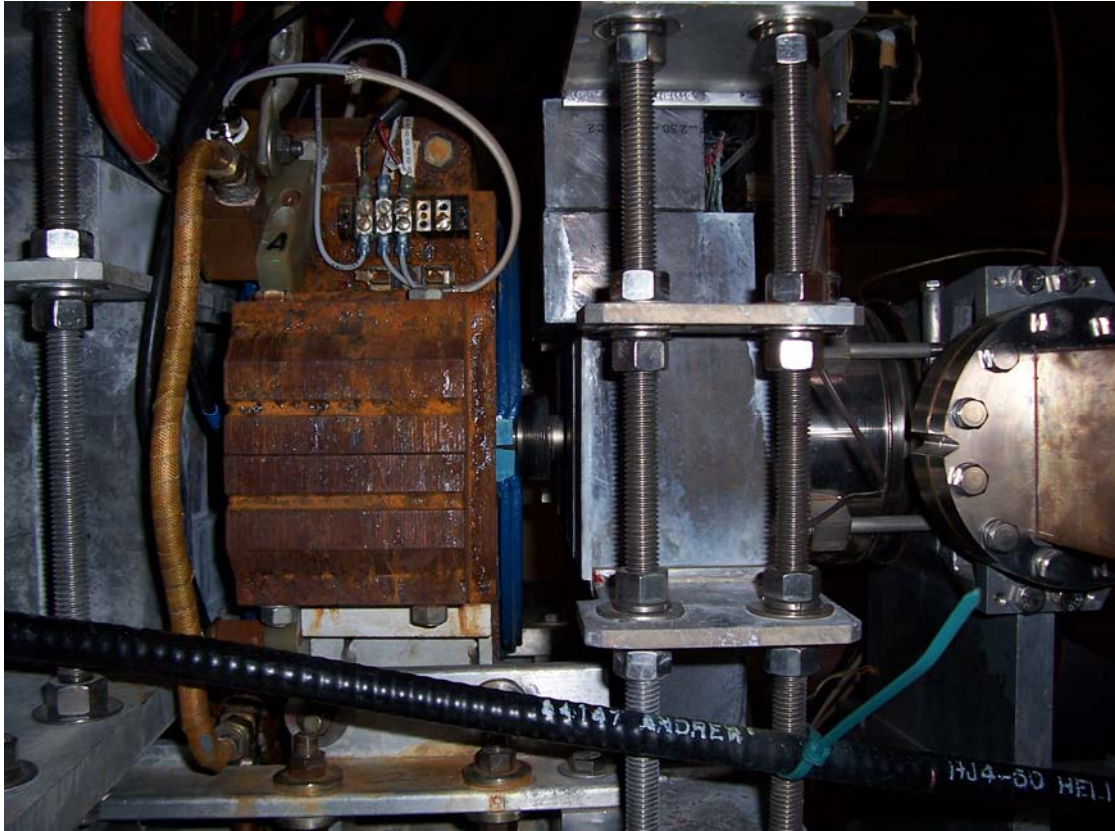
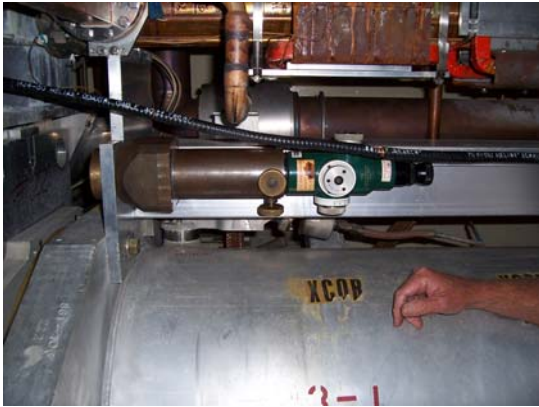
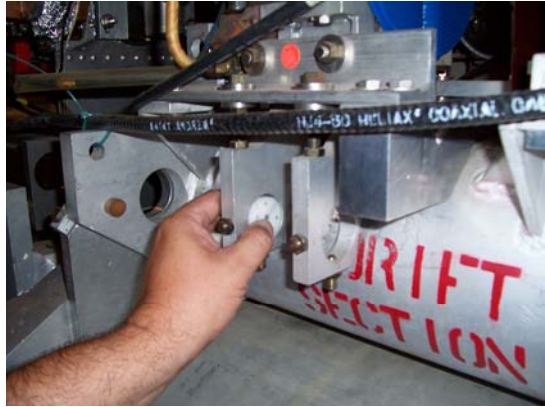
- Visual inspection of the bellows showed a kink compatible with the problem.
- The alignment scope and the level measurements repeat: the quad appeared to be in the correct position and orientation. Two neighboring quads (821 and 901) were also checked.
- While setting an optical transit, it was found that 2 bolts holding the aisle side alignment holes in place with the quad were missing. After replacing and tightening the two bolts, the alignment scope read a 40 mil displacement in x. The quad was moved accordingly: 40 mils towards the aisle.
- The jig transit line was created using jackpoints 2-8 and 3-1 with verification on 2-9. The same three quads were read and 991 showed another 40 mil displacement in x. The alignment scope was used again to perform this move (and control the height and orientation).

- Quad LI02-991 was moved 80 mils towards the aisle.
- The alignment holes of this quad have been tagged-off to indicate that they should not be used in the future. The use of these fiducials as-is will not result in the correct positioning of the device relative to the beamline.
