Accelerator Safety Audit NLCTA 2006

Thursday, July 13, 2006

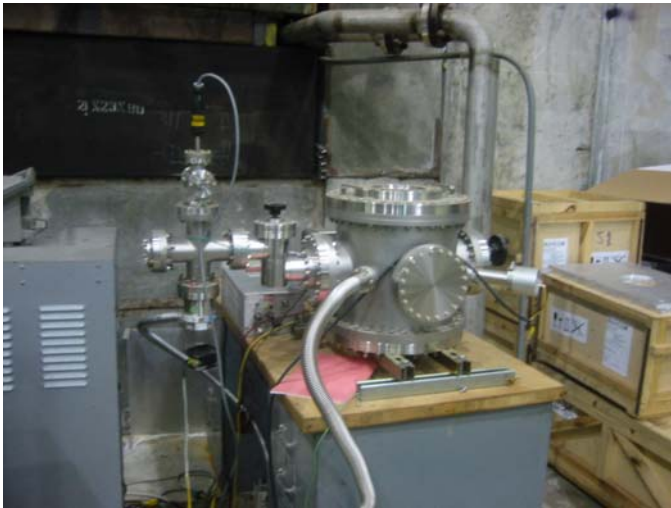
Figure 2 NLC Inertia Sensor Chamber

A commercial vacuum test chamber at the west end of End Station B. This chamber just meets the registration requirement of 1 cu.ft. times 1 atm. The only concern would be on pressurizing, there was no pressure relief valve. MESI-376 was given to the device, which is presently not in service.

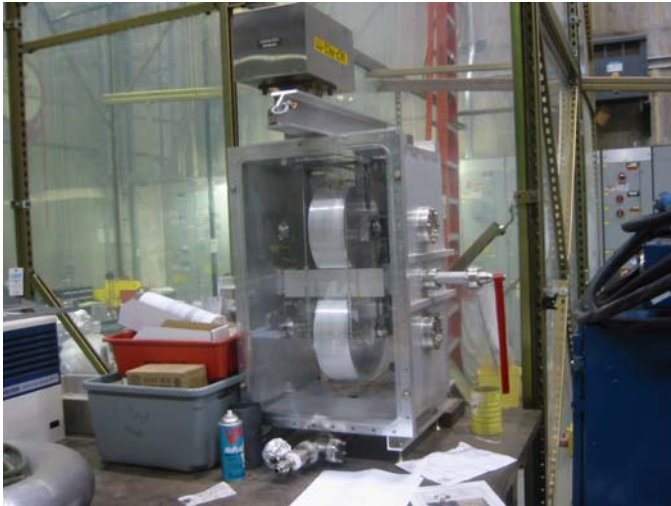
Figure 4 NLC Collimator Test Chamber

A chamber for a collimator prototype test. This is no longer being used and is safe in its present state.

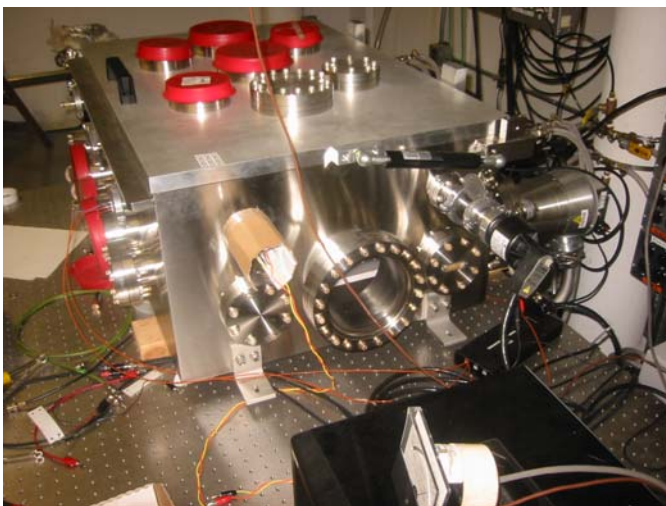
Figure 5 E-163 Chamber

A rectangular chamber from Stanford campus is being used for E-163. It has been registered as MESI-375.

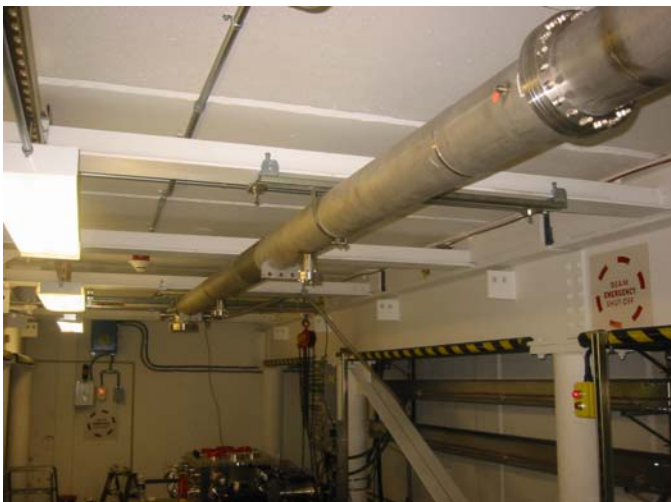
Figure 6 Laser Light Pipe

The laser light pipe in the E-163 experimental hut is considered to be a dispersed energy storage and does not need a SLAC registration. It might be advisable to put a pressure relief valve on it.

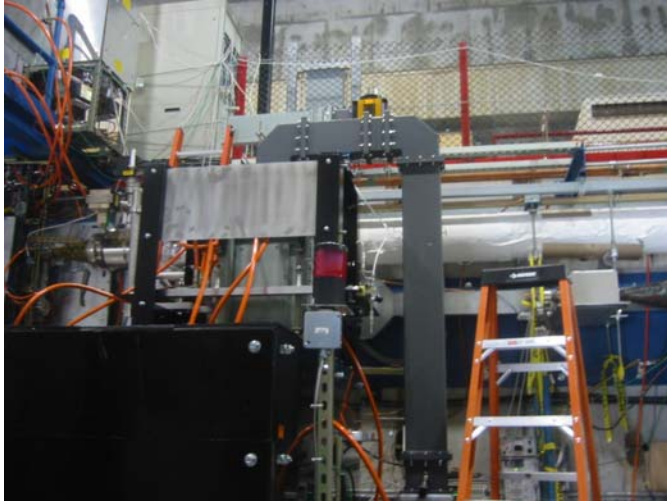
Figure 7 Large Rectangular Waveguide

There is a rectangular waveguide by the 8-Pack stand. It is considered to be a dispersed energy storage and does not need a SLAC registration. It does have pressure relief valves.

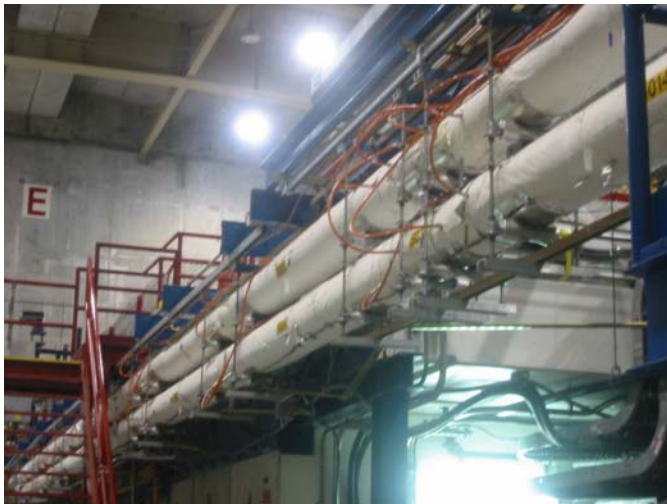
Figure 8 Large Round Waveguide Delay Line

There is a large round waveguide delay line above the NLCTA bunker. It is considered to be dispersed energy storage and does not need a SLAC registration.

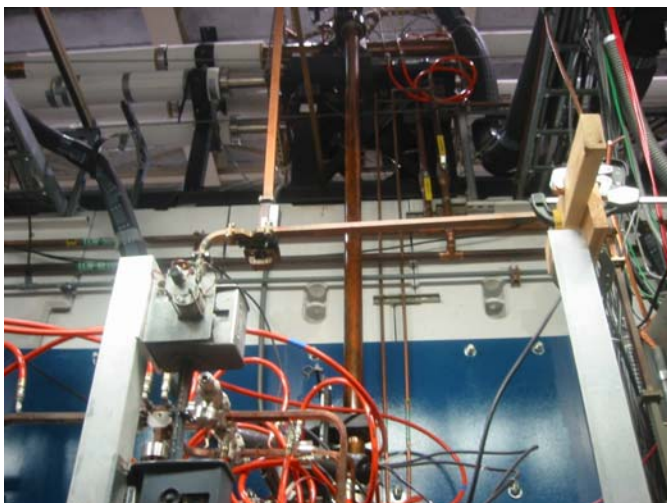
Figure 9 Small Round and Rectangular Waveguide

The small round and rectangular wave guide are considered to be dispersed energy storage and do not need SLAC registration.

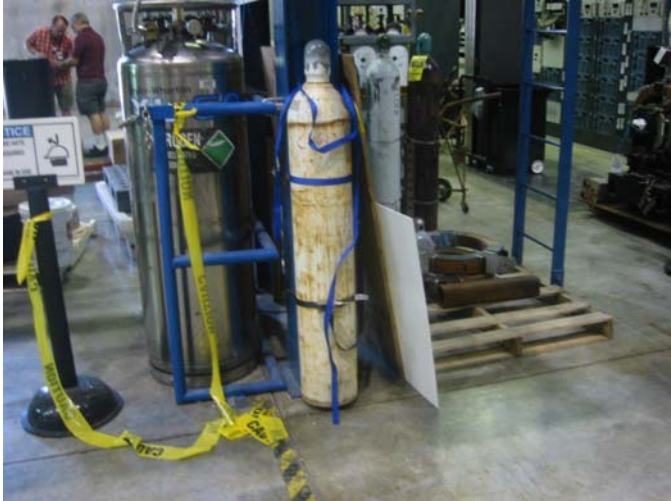
Figure 10 Commercial Gas Bottles and Commercial Dewars

There were commercial gas bottles and commercial dewars in End Station B. They are inspected by another agency and do not require SLAC registration as pressure vessels.

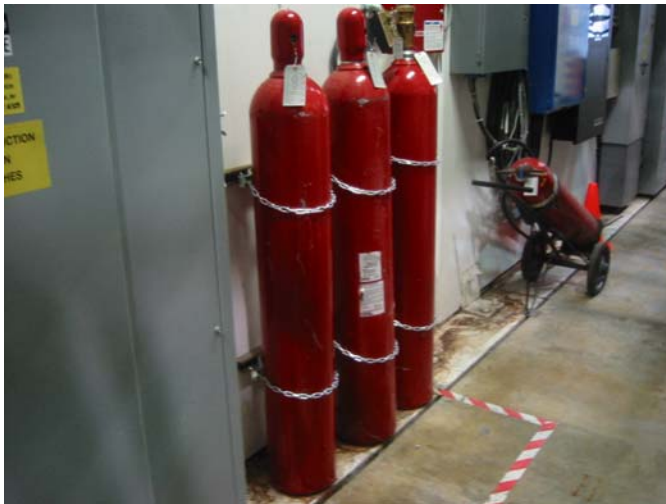
Figure 11 Commercial Fire Protection Gas Bottles

There were fire protection gas bottles in End Station B. They are inspected by another agency and do not require SLAC registration as pressure vessels.

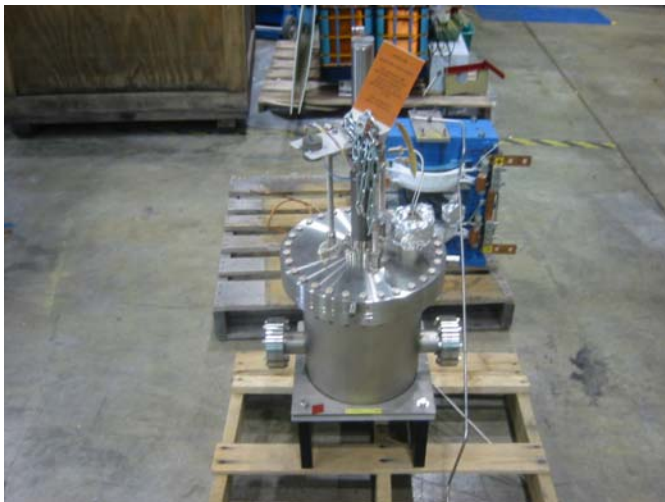
Figure 12 Stored Small Vacuum Chamber

There was a small vacuum chamber being stored on a pallet in End Station B, which is below the size required for SLAC registration.

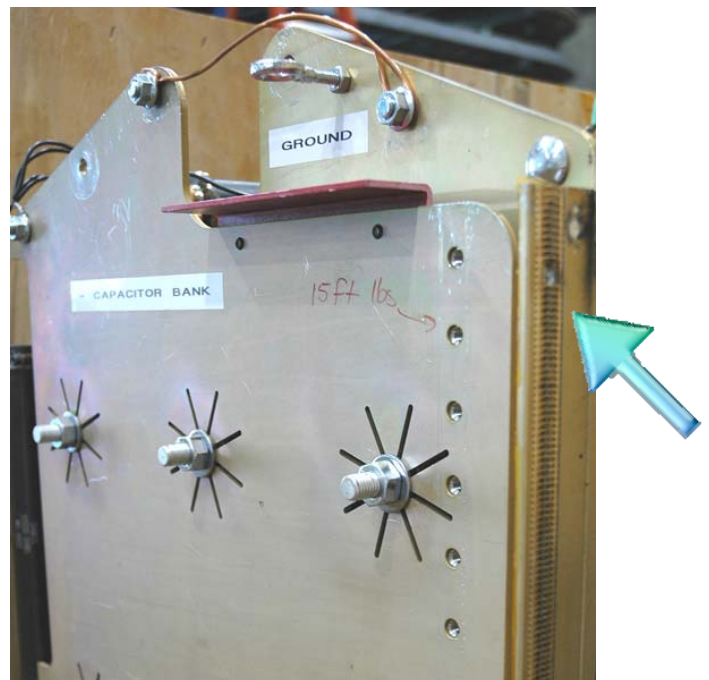
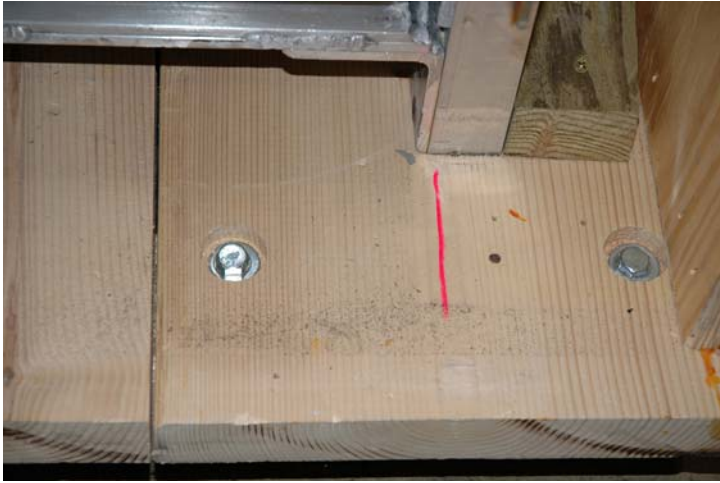
Thank you kindly for your prompt attention to the new modulator equipment at NLCTA. As you suspected, the slightly worn (apparently arc-damaged) beryllium copper connector on one of the cabinets was a source of Beryllium dust. There were levels of Beryllium that exceeded the DOE housekeeping standard on that cabinet (but not on the second cabinet which did not have damaged connectors).

The connector strip showed signs of arc damage at the top.

There was visible dust on the wood container that housed the same modulator cabinet. A sample here recorded 15 micrograms per 100 square centimeters.

I cleaned the connector strip and bottom of the cabinet as well as I could. Please let me know when you remove the cabinet from the wood box so that I can inspect it prior to disposal, or storage.
