# Accelerator Safety Audit NLCTA 2006

Thursday, July 13, 2006

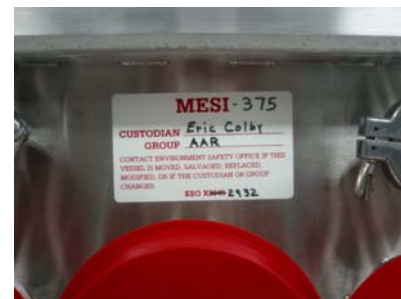
**Figure 5 E-163 Chamber**

A rectangular chamber from Stanford campus is being used for E-163. It has been registered as MESI-375.

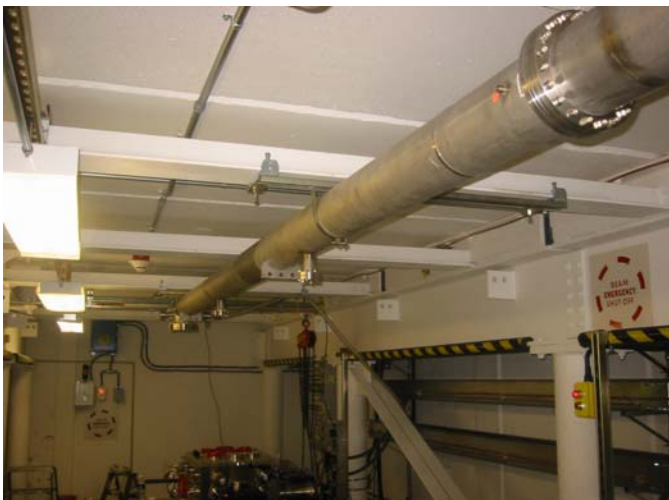
**Figure 6 Laser Light Pipe**

The laser light pipe in the E-163 experimental hut is considered to be a dispersed energy storage and does not need a SLAC registration. It might be advisable to put a pressure relief valve on it.

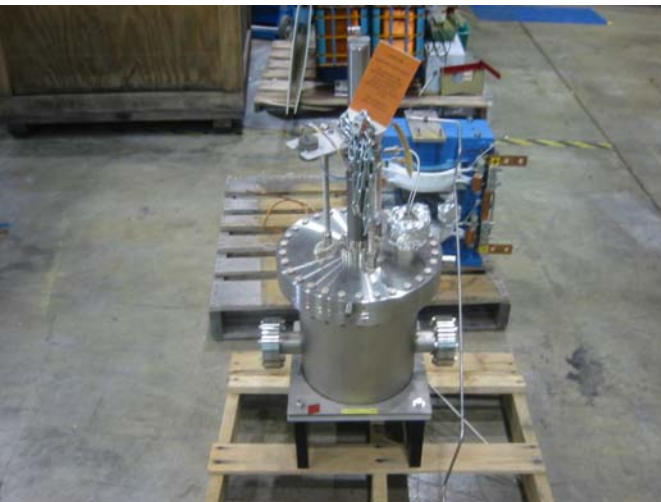
**Figure 12 Stored Small Vacuum Chamber**

There was a small vacuum chamber being stored on a pallet in End Station B, which is below the size required for SLAC registration.
