# Accelerator Safety Audit NLCTA 2006

Thursday, July 13, 2006

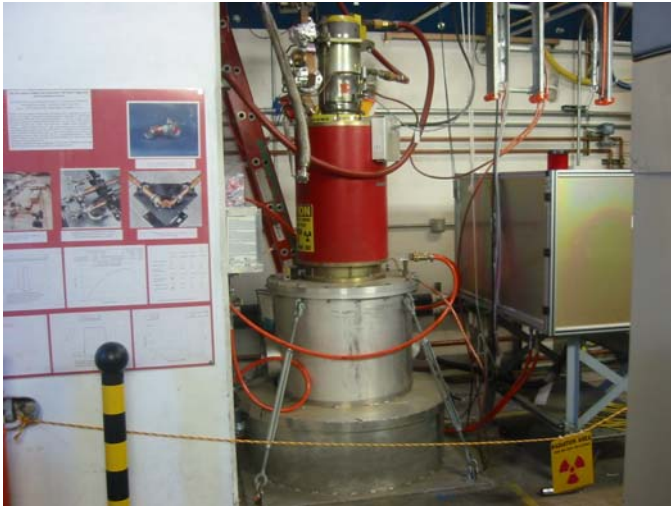
**Figure 1 Klystron Pulse Tank**

Klystron pulse tank made to SLAC drawing number AD-238-231-00-R7, MESI-253.214. This tank can be evacuated as part of the oil filling process.

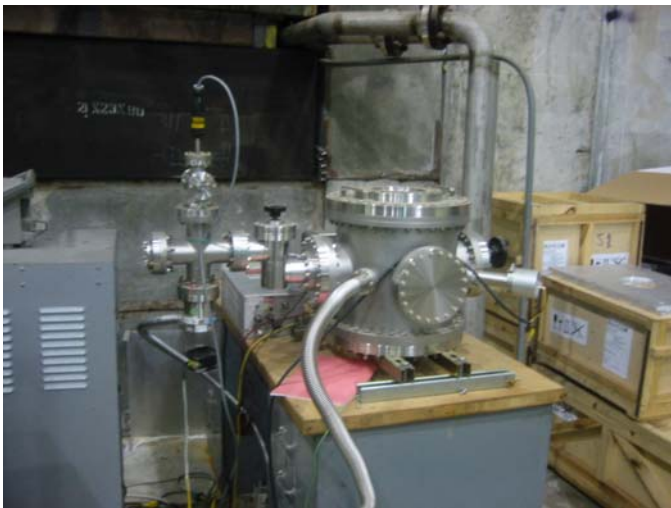
**Figure 2 NLC Inertia Sensor Chamber**

A commercial vacuum test chamber at the west end of End Station B. This chamber just meets the registration requirement of 1 cu.ft. times 1 atm. The only concern would be on pressurizing, there was no pressure relief valve. MESI-376 was given to the device, which is presently not in service.

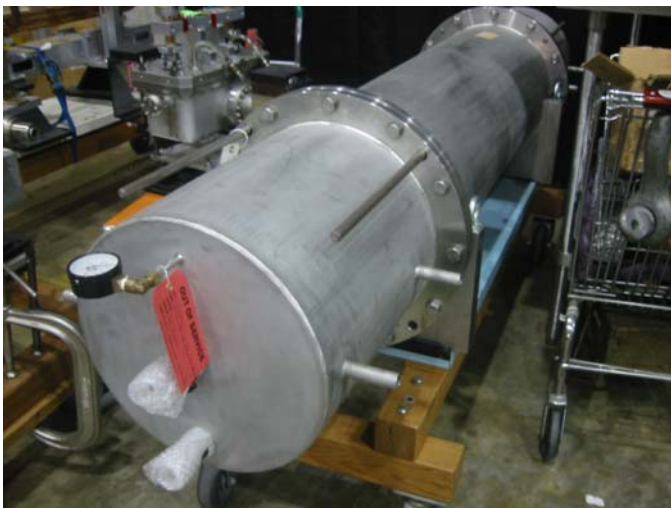
**Figure 3 Accelerator Shipping Container**

A shipping tank, about 1 foot in diameter and 8 feet long. This tank has valves and fitting and no pressure relief valve. This tank does not belong to SLAC and is labeled "Out of Service".

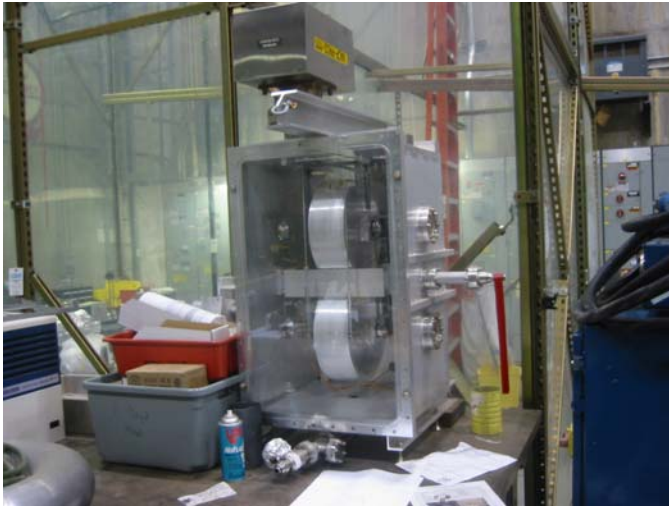
**Figure 4 NLC Collimator Test Chamber**

A chamber for a collimator prototype test. This is no longer being used and is safe in its present state.

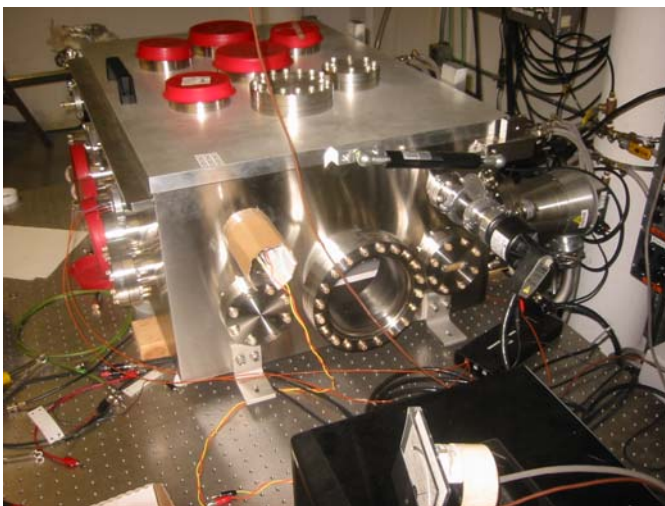
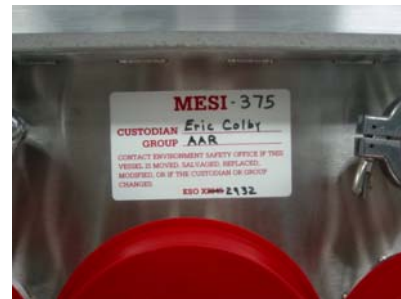
**Figure 5 E-163 Chamber**

A rectangular chamber from Stanford campus is being used for E-163. It has been registered as MESI-375.

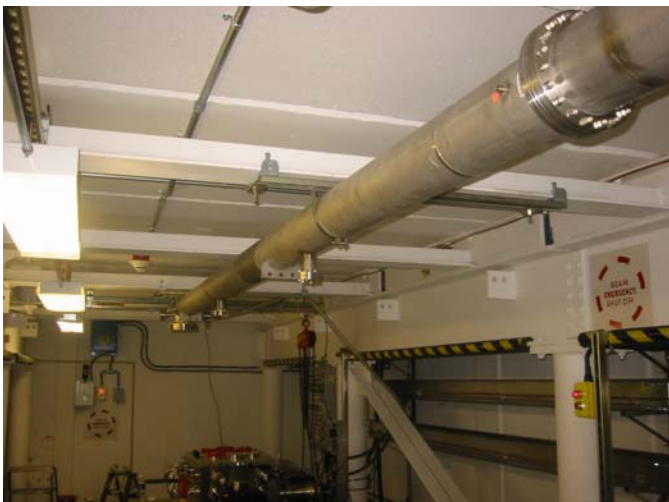
**Figure 6 Laser Light Pipe**

The laser light pipe in the E-163 experimental hut is considered to be a dispersed energy storage and does not need a SLAC registration. It might be advisable to put a pressure relief valve on it.

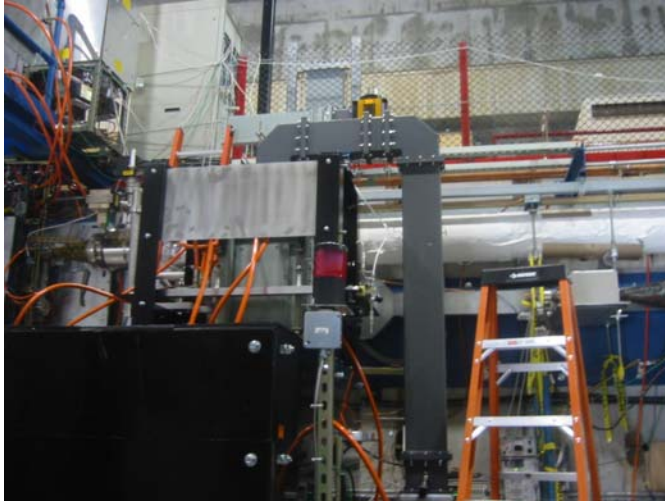
**Figure 7 Large Rectangular Waveguide**

There is a rectangular waveguide by the 8-Pack stand. It is considered to be a dispersed energy storage and does not need a SLAC registration. It does have pressure relief valves.

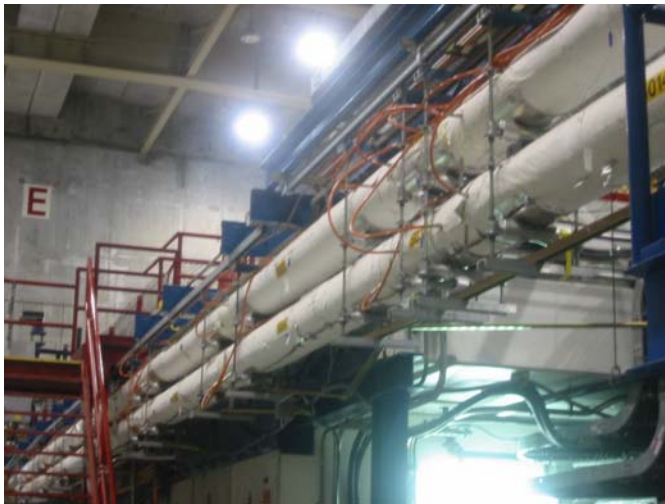
**Figure 8 Large Round Waveguide Delay Line**

There is a large round waveguide delay line above the NLCTA bunker. It is considered to be dispersed energy storage and does not need a SLAC registration.

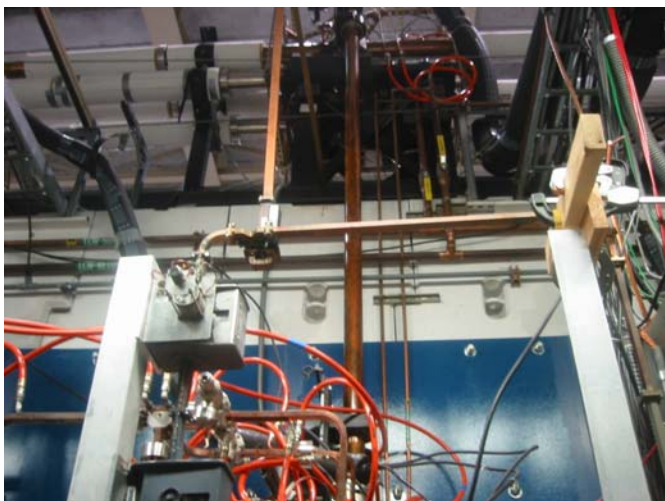
**Figure 9 Small Round and Rectangular Waveguide**

The small round and rectangular wave guide are considered to be dispersed energy storage and do not need SLAC registration.

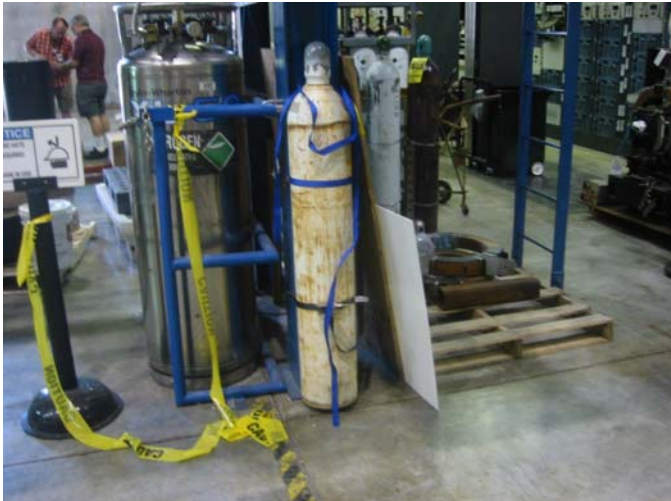
**Figure 10 Commercial Gas Bottles and Commercial Dewars**

There were commercial gas bottles and commercial dewars in End Station B. They are inspected by another agency and do not require SLAC registration as pressure vessels.

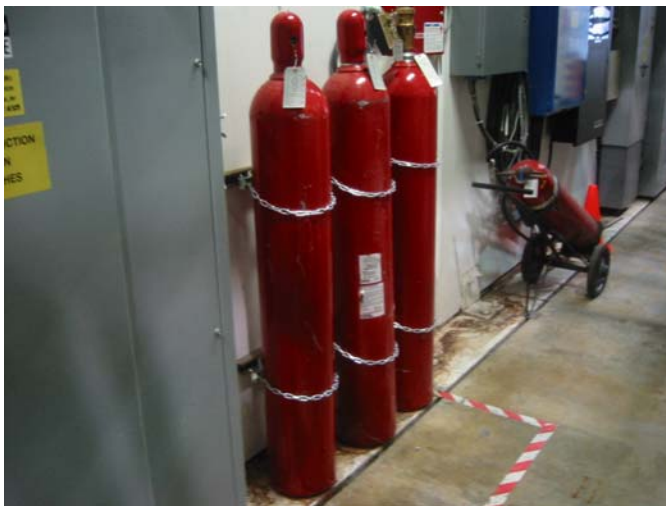
**Figure 11 Commercial Fire Protection Gas Bottles**

There were fire protection gas bottles in End Station B. They are inspected by another agency and do not require SLAC registration as pressure vessels.

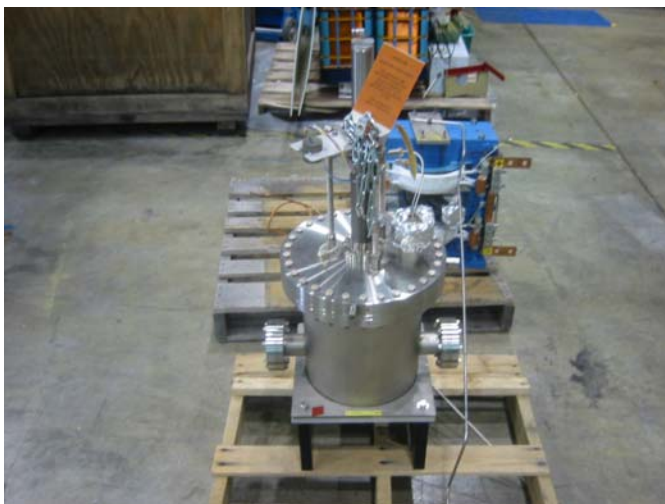
**Figure 12 Stored Small Vacuum Chamber**

There was a small vacuum chamber being stored on a pallet in End Station B, which is below the size required for SLAC registration.

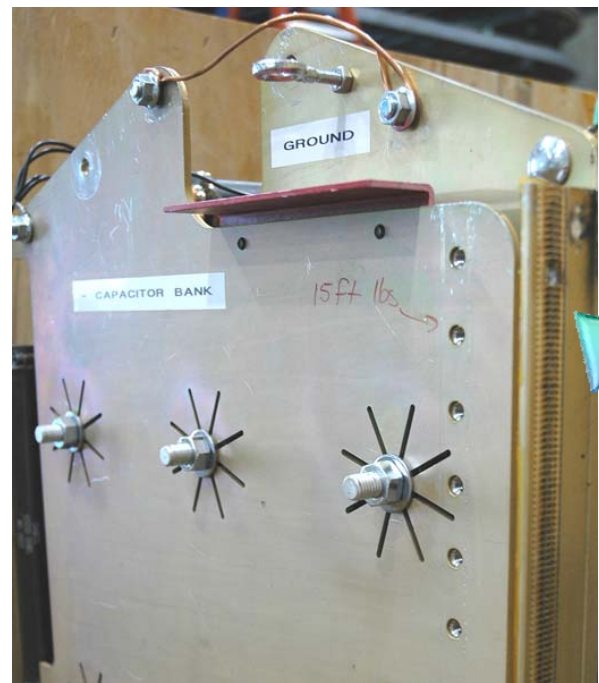
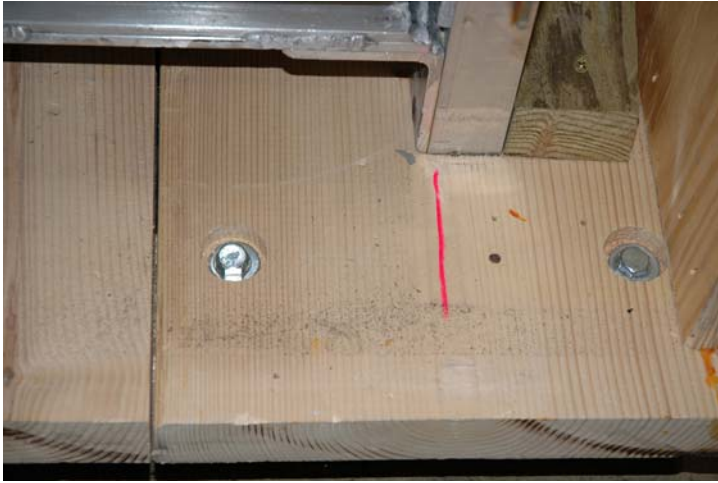
Thank you kindly for your prompt attention to the new modulator equipment at NLCTA. As you suspected, the slightly worn (apparently arc-damaged) beryllium copper connector on one of the cabinets was a source of Beryllium dust. There were levels of Beryllium that exceeded the DOE housekeeping standard on that cabinet (but not on the second cabinet which did not have damaged connectors).

The connector strip showed signs of arc damage at the top.

There was visible dust on the wood container that housed the same modulator cabinet. A sample here recorded 15 micrograms per 100 square centimeters.

I cleaned the connector strip and bottom of the cabinet as well as I could. Please let me know when you remove the cabinet from the wood box so that I can inspect it prior to disposal, or storage.
