SNS Modulator Fire of Friday, March 21, 2008

Fire Marshal Review

Appendix A – Report of Keith Jobe, 3/28/2008

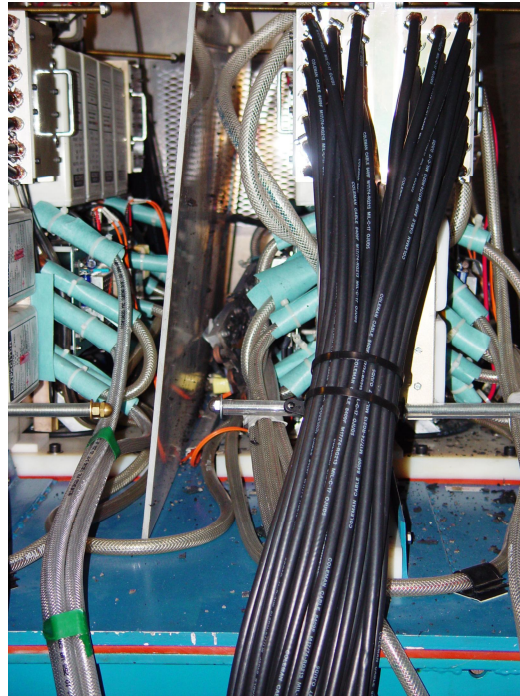
Appendix A of this report addresses Keith Jobe's review of the technical aspects of the SNS modulator internal explosion. During a discussion on March 21st, Keith stated that the electrical explosion was initiated by an electrical component failure resulting in a short and complete discharge of the modulator's capacitor bank through a pair of IGBT semiconductor switches, resulting in the destruction of both switches.

Photo 3 – Center Module (note fragments)

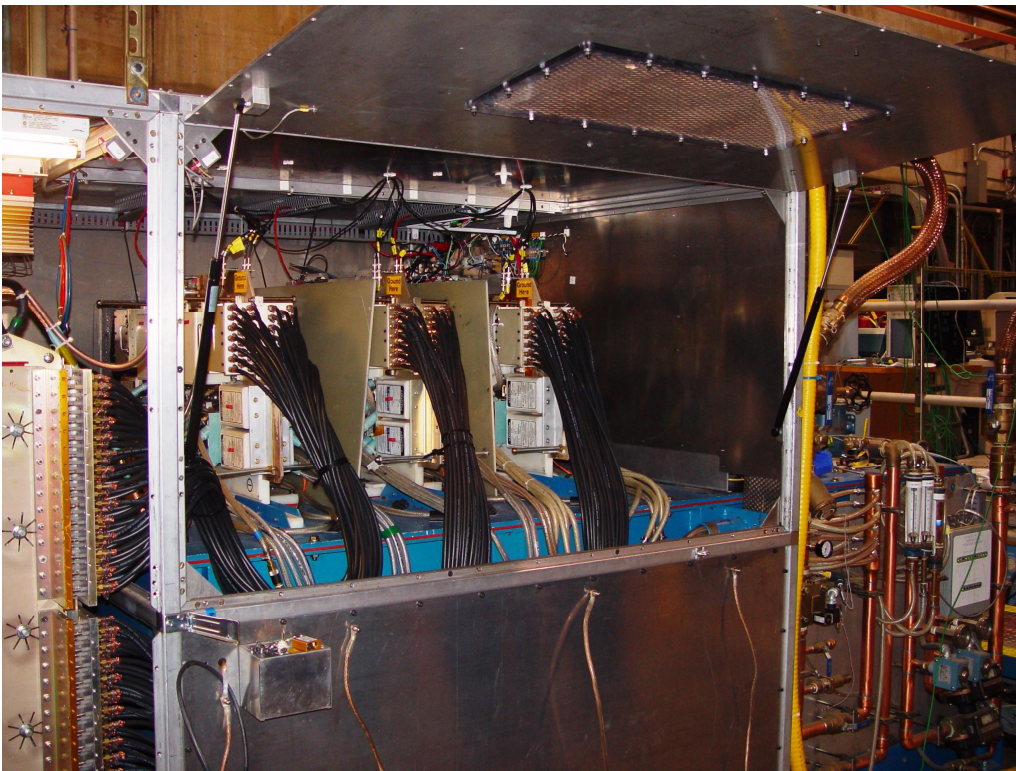
Photo 2 – Face of SNS Modulator With Side Panel Open
(Center Module has the blown switches; damage not visible in this photo)
