Stanford Linear Accelerator Center

Validation Review

NLCTA Restart Plan

May 2005

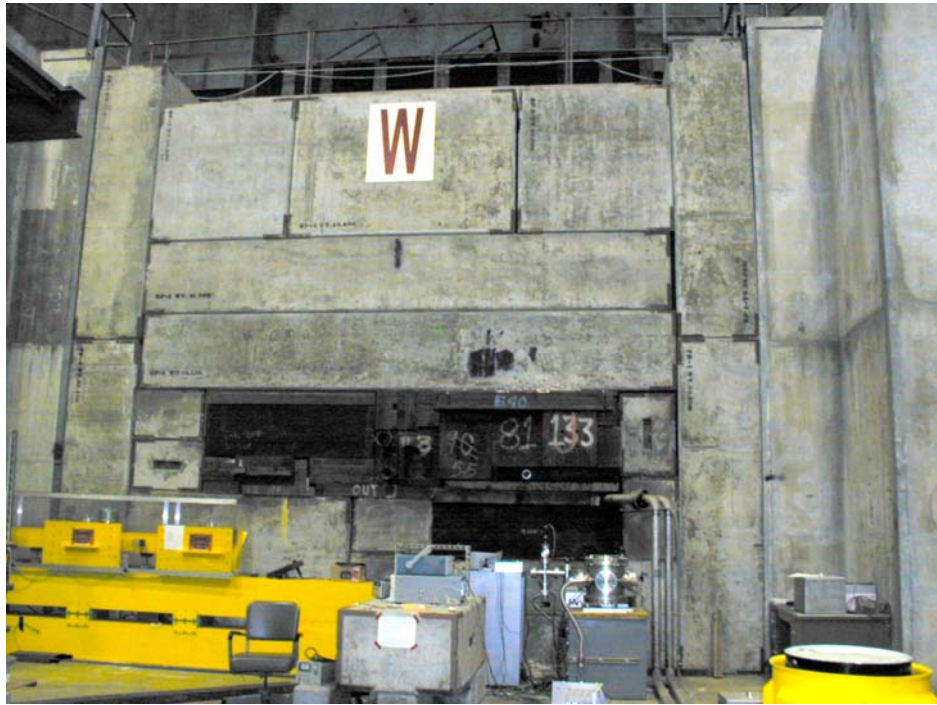
At the west end of the building, the B Target Room concrete shielding blocks are stacked on top of each other without any seismic restraints (see picture in Appendix A), the only means to resist any seismic forces are the friction between the blocks. Thus, the area inside of the building at the west end is potentially unsafe during a major earthquake. The same can be said about the items stored on the mezzanine on the west side of the building. These items are stored without proper seismic restraints. Thus, either the items should be properly secured or should be removed to a new storage area. These conditions existed prior to the Laboratory’s shut down and should not hinder the restart of ESB. These items are listed in the existing seismic upgrade plans for the Laboratory but have not yet been funded. We recommend that the funding priority be re-assessed in light of the ever increasing use of this facility.

At the west end of the building, the concrete shielding blocks are stacked on top of each other without any seismic restrains (see picture on page 4), the only means to resist any seismic forces are the friction between the blocks. Thus, the area inside of the building at the west end is potentially unsafe during a major earthquake. Same can be said about the items stored on the mezzanine on the west side of the building. These items are stored without proper seismic restraining means. Thus, either the items should be properly secured or should be removed to a new storage area. While, these conditions have been existed prior to the Labs shut down and should not hinder the restart of the End Station “B.” These issues should be considered for the future safety plan of the End Station “B.”

Picture of concrete shielding block stacked without seismic ties.

In general the contents of the building meet the intent of the “life safety” requirements of the SLAC EqSC. Thus from seismic safety point of view, the restart of NLCTA should not be delayed. However, it is strongly suggested to carry out the recommendations in this report during pre- or post-restart in order to enhance the “life safety” of the building.

Number	Recommendation	Target Date
1	Reassess the priority for seismic upgrades in ESB.	October 1, 2005
2	Schedule a follow-up assessment in September to assess the status of recommendations in Appendix A.	September 30, 2005
