## Summer / Fall 2004 Downtime AEG Preparation Work

# Summer / Fall 2004 Downtime AEG Week 2 Summary

## Summer / Fall 2004 Downtime AEG Week 4 Summary

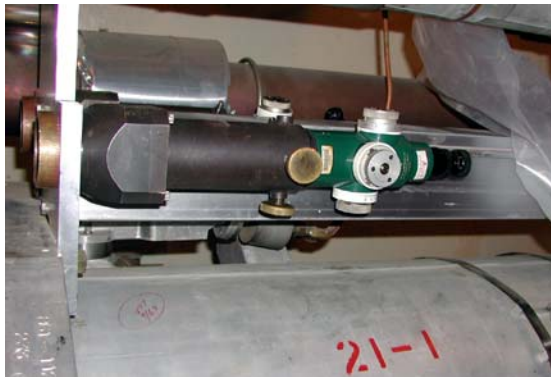
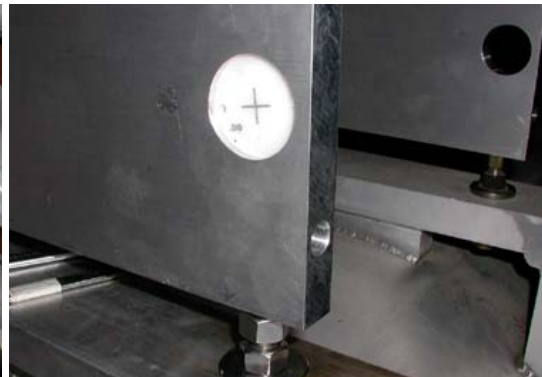
Mark 6 points for the 2 walls construction. The final decision was to have the walls vertical (not perpendicular to the accelerator-injector plane)

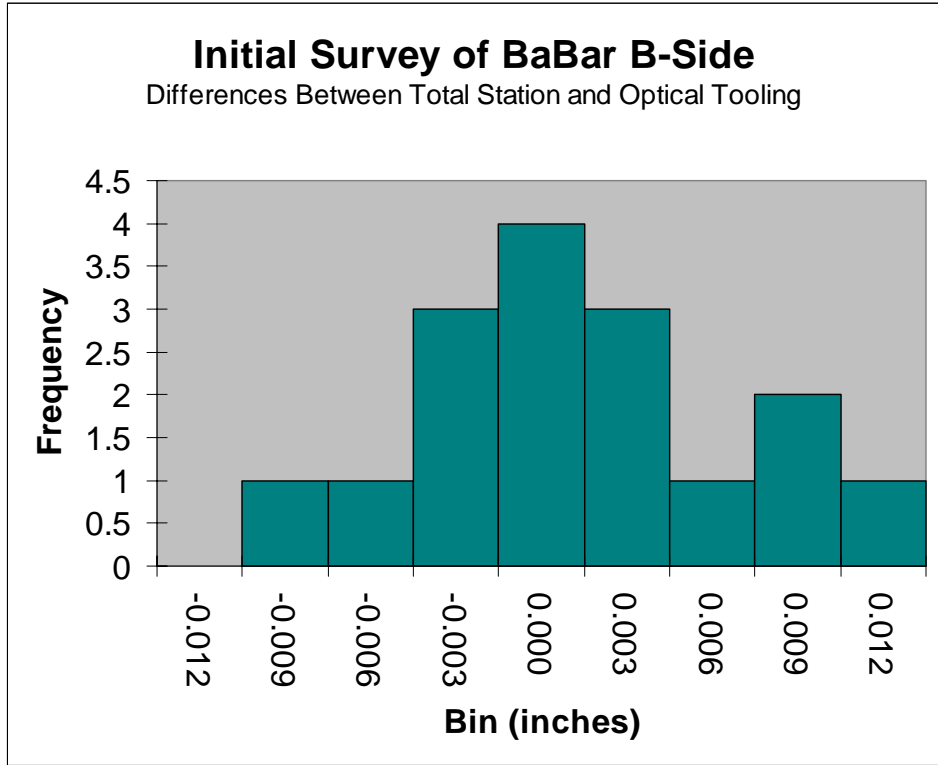
The comparison between the TC2002 and the optical survey was very good except for point E. Presented on the next page is the histogram of the distribution of all possible X-distances between 2 points on the same side, excluding E:

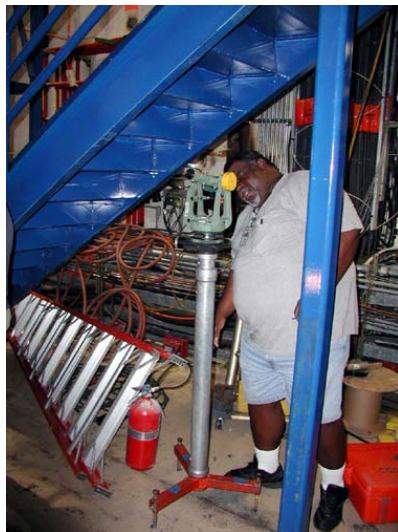
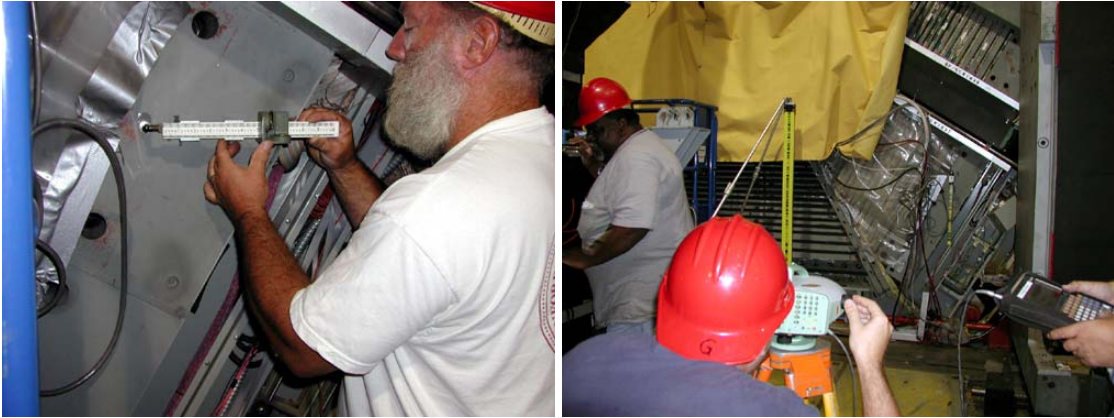
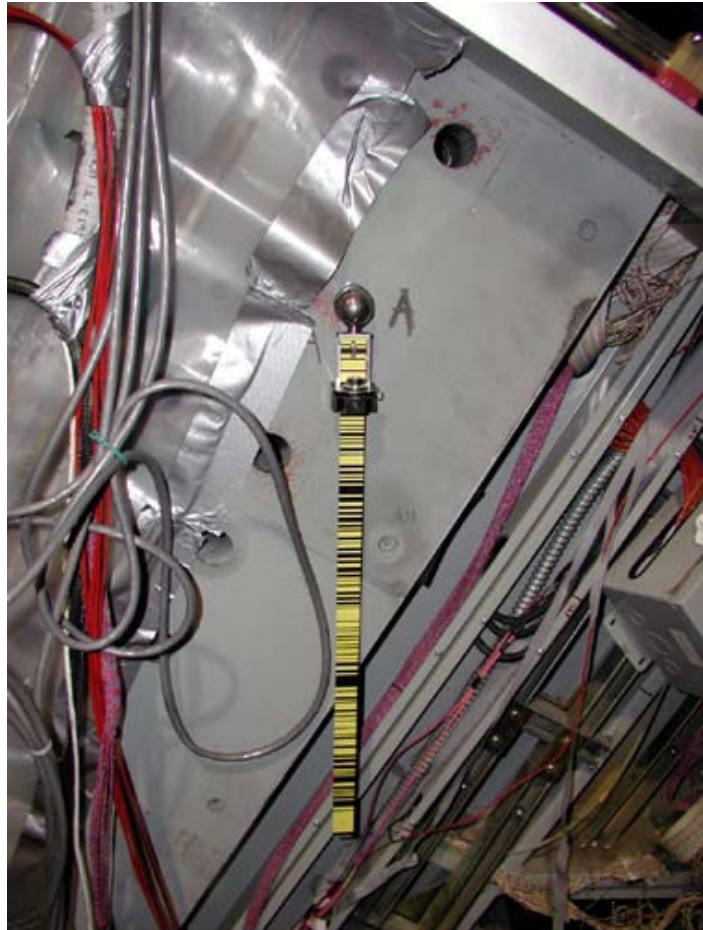
The TC2002 and the level observations were combined in a similar fashion as in the initial survey. In particular, the a-priori standard deviations were identical: 100  $\mu\text{m}$  for distances, 50  $\mu\text{m}$  for height differences, 50  $\mu\text{m}$  over the distance in meters for horizontal angles, 70  $\mu\text{m}$  over the distance in meters for vertical distances.

Again the comparison between the total station/level and the optical tooling surveys was very good except for ball E.

A 7-parameter transformation on all points was used to compare both Monday's and Friday's survey showing that the detector did not move significantly (from this end) between the 2 surveys. Here are the results:

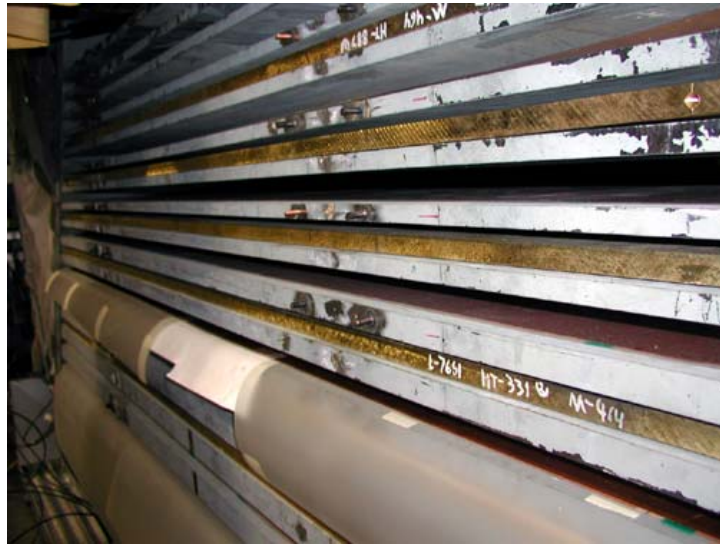
- Monday August 23
  - o This survey is designed to check the detector after the installation of the brass plates in the lower part of the detector.

- o It is based on the same observation scheme as the one described in week 2. The problems encountered this time:
  - Loss of tooling ball socket J after the 4 TC2002 set-ups and before the optical tooling reading. A new socket, called J2, was installed for future surveys. Its X offset was read and an additional total station set-up was made to determine its position.
  - The tooling ball socket for F1 seems to have some glue in the hole and/or the nearby concrete fillet blocks the cup from sitting down fully: special attention should be made in choosing the appropriate Hubbs cup (it may need a short shank).

The TC2002 data adjustment based on the previous coordinates show no significant movements. The 2 sets of optical tooling data match the adjusted X-coordinates. The level data are set apart right now in order to study the non-repeatability of F1 in the Y direction.

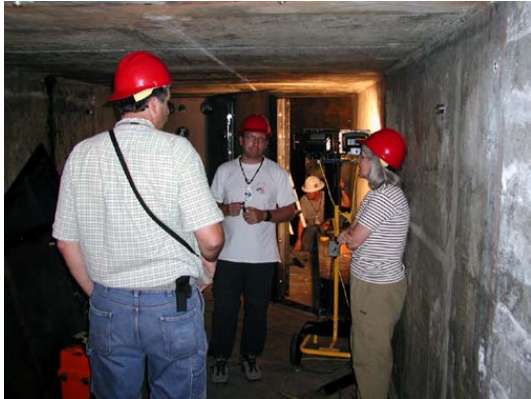
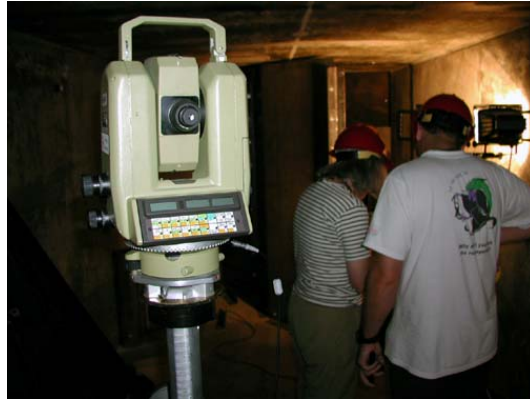
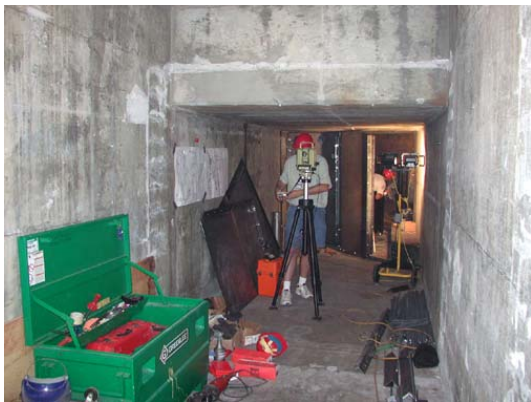
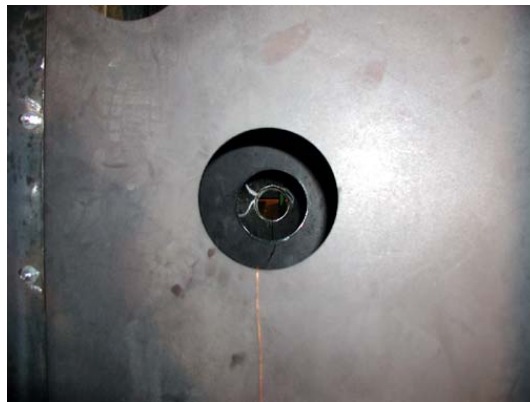
- Monday August 23
  - o Read the upstream wall A: found that it was placed 7/8" too high and 3/8" too close to the tunnel wall. It was moved and ended still 1/4" too high and 1/4" too close. The bolts have not been tightened yet.

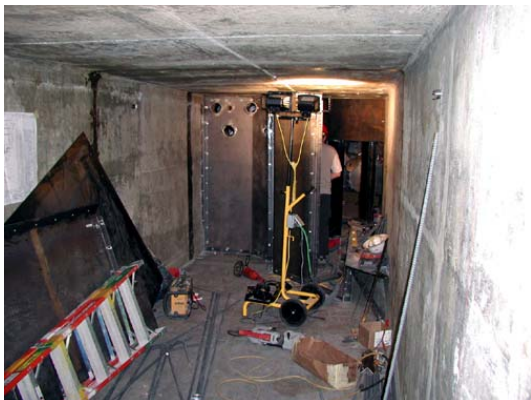
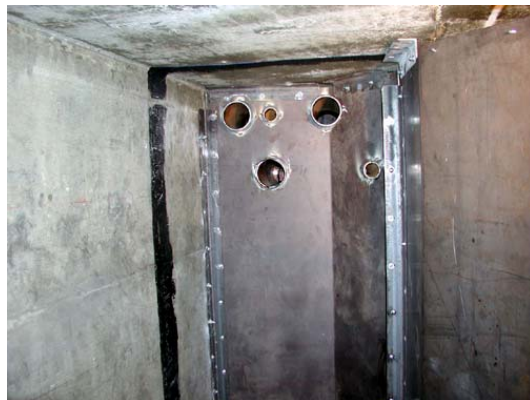
- Tuesday August 24

- Thursday August 26  
 o The following results were sent:

Pipe	X (in)	Y (in)
Beam Line Pipe 1	0.14	-0.26
Beam Line Pipe 2	0.00	0.08
Beam Line Pipe 3	0.21	-0.00
Beam Line Pipe 4	-0.37	-0.01

Laser Pipe (East) 1	-0.14	0.13
Laser Pipe (East) 2	0.08	0.26
Laser Pipe (East) 3	0.13	0.28
Laser Pipe (East) 4	-0.78	0.31
Laser Pipe (West) 1	0.10	-0.07
Laser Pipe (West) 2	0.08	-0.09
Laser Pipe (West) 3	0.13	0.22
Laser Pipe (West) 4	-0.28	-0.01

These are as-built values with the following convention: the numbering starts from the linac and goes towards the injector room. In other words: 1 is South and 4 is North.

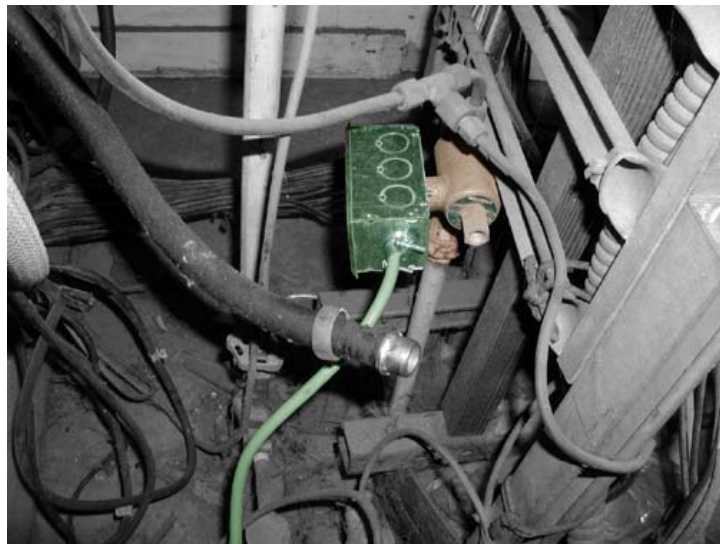
- Wednesday August 25
- Tom Graul arranged for the installation of the air solenoid in 2-9: a temporary power cord (see the enhanced picture above) is attached directly to the solenoid and can be plugged into any of the regular electrical outlets on the other side of the panel in order to move the target into the “in” position. The target was tested and produced the following image in the “blue room”.

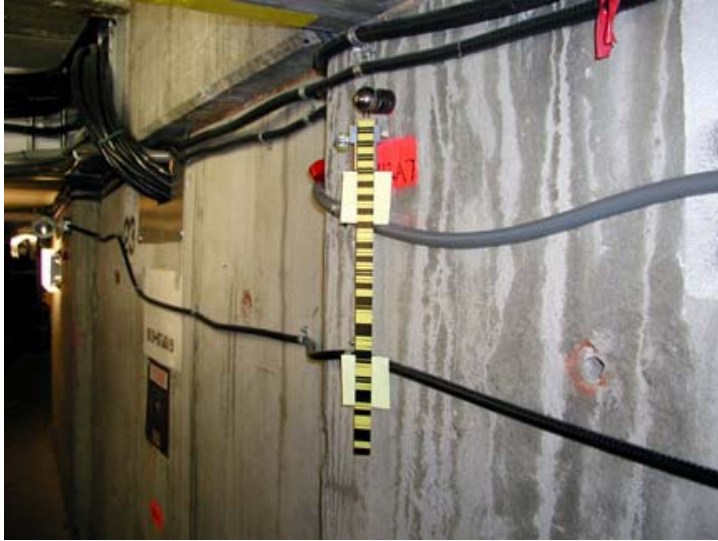
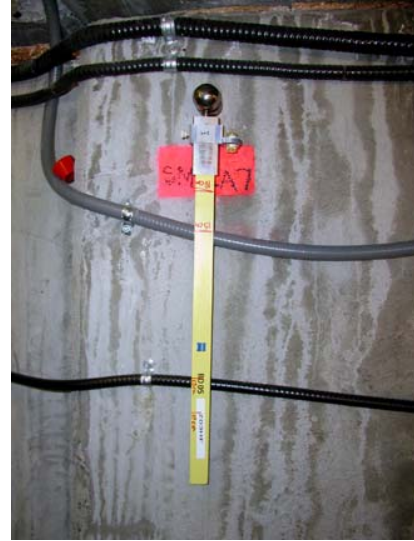
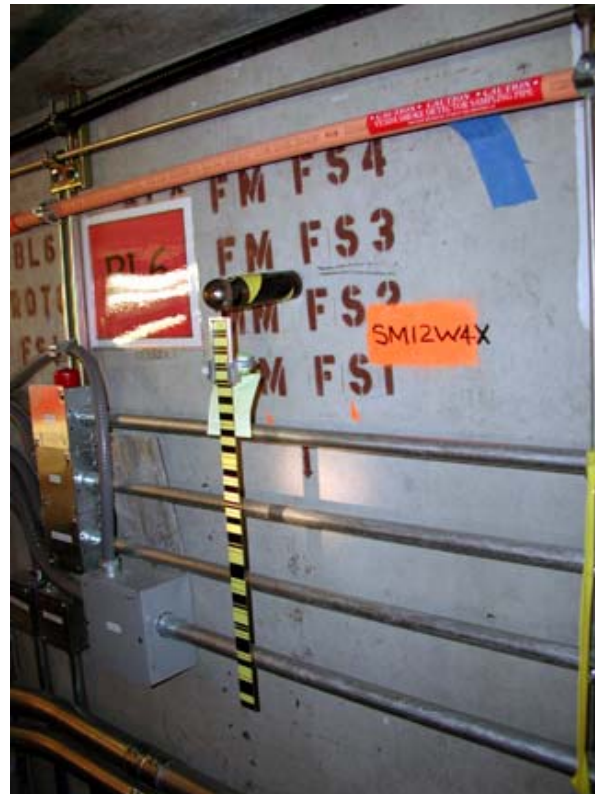
- Tuesday August 31
  - o Start level shots to wall points
  - o Add extension to wall monuments in areas where light fixtures prevent placement of regular tooling. (Note sticky notes added to back of rod to indicate “safe zone” to read bar code.)

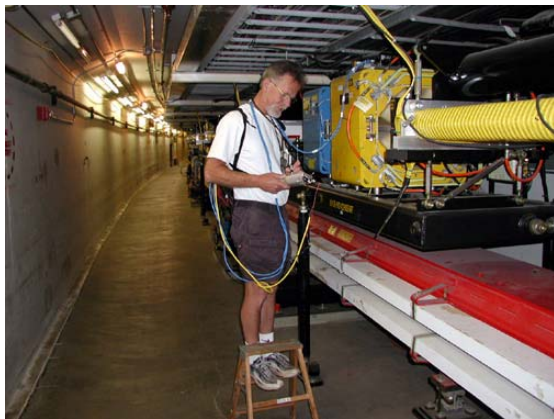
- Wednesday September 8
  - o Tiltmeter measurements of low energy quadrupoles

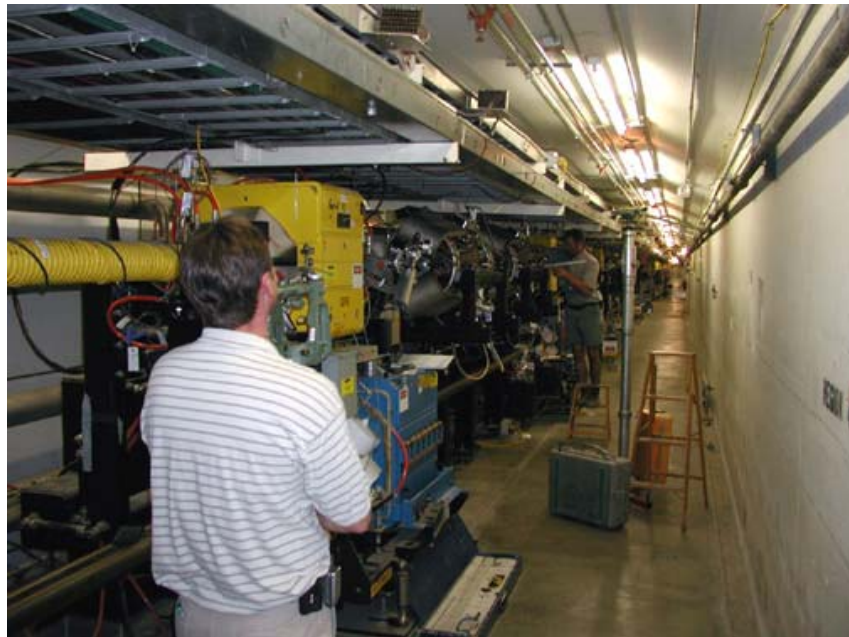
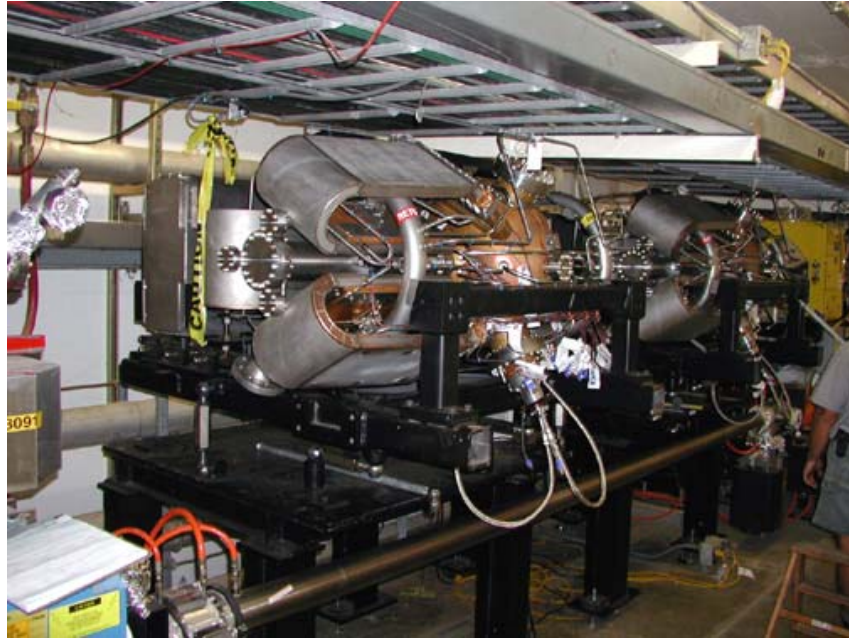
- PEP-II R4: set the 2 new RF cavities  
The cavities were set through optical tooling set-ups based on the flanges of the neighboring quads.

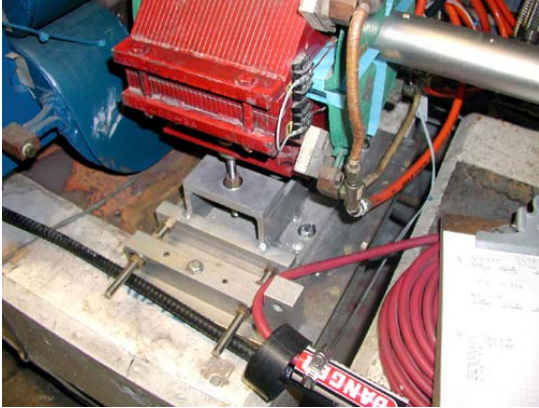
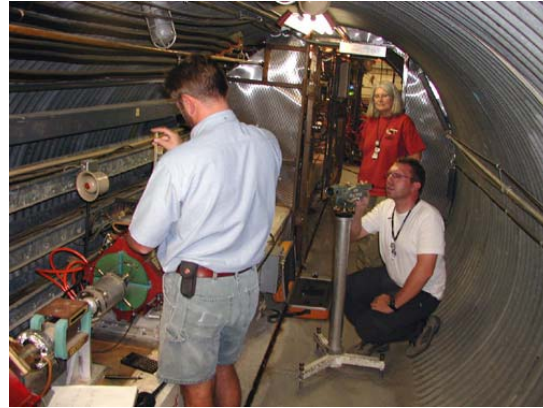
- SPEAR3: as-built of 9S in preparation for the installation of a new undulator for a new beamline (BL12) in Summer of 2006
- SDR: set the 2 quadrupoles (QD1295 and QF1315) after plate installation for correct moves

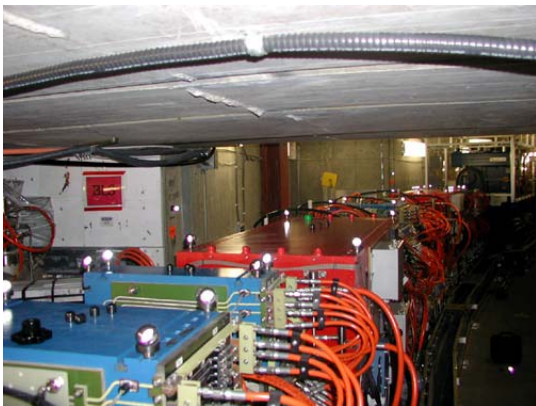
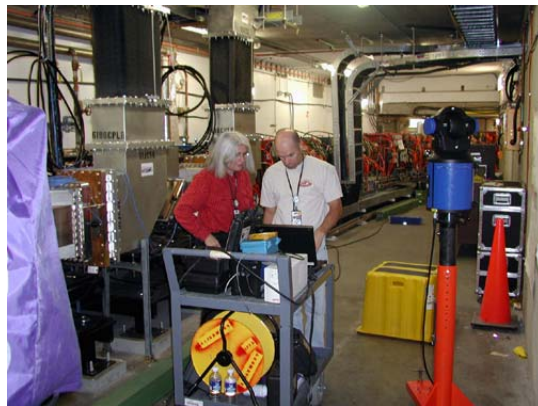
- Finish moving vacuum chambers and map cells 18 and 1.

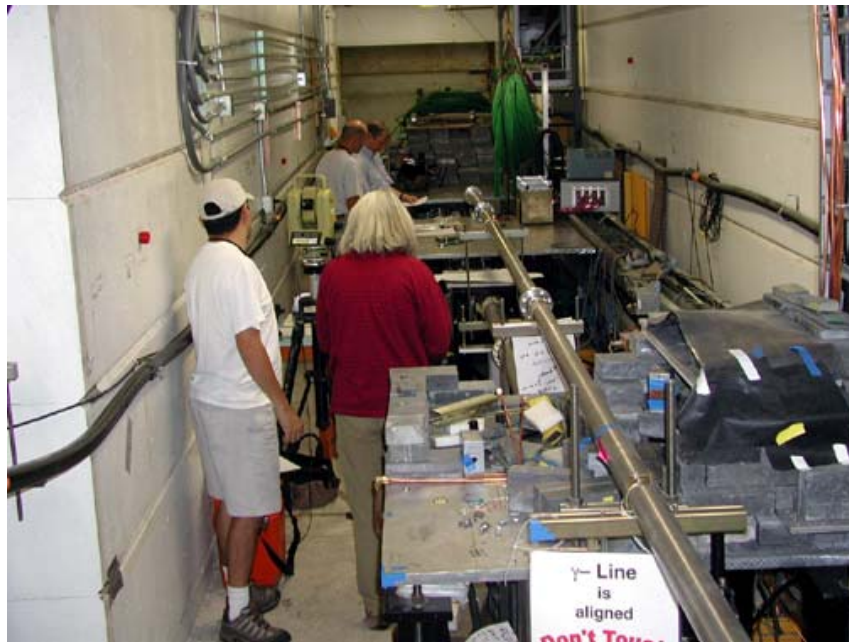
- Thursday September 23
  - FFTB E166
    - Set height and scribe line on table
