***SLAC Injury Reduction Plan of Action (POA)
Alignment Engineering Group***

***May 11, 2006
11:00 AM, Trailer 283***

Actionable Injury Prevention Idea #1

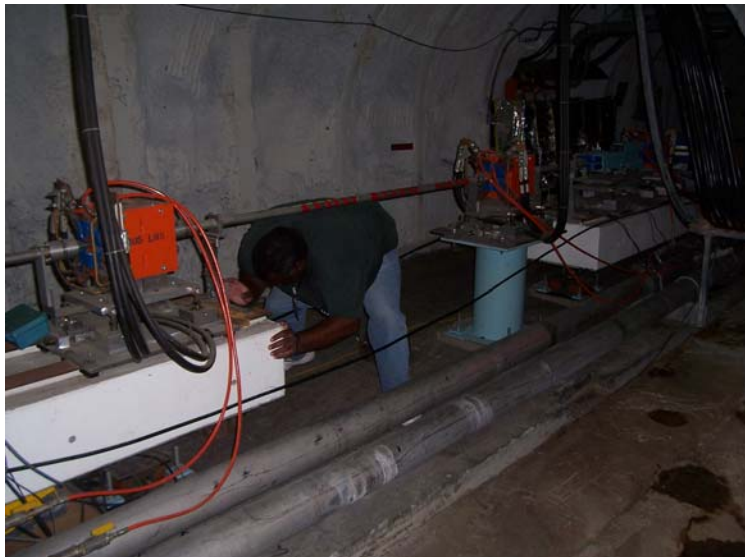
- 1) Trip hazard due to poor lighting: there is not enough light even if all burnt out bulbs were replaced.
- 2) When entering the tunnel through the Research Yard ramp and passed the wooden door, one has to step over an open drainage trench and water pipes to duck under the arc beamline before being able to access the aisle way. This trench is partially hidden by the pipes and in main access way (Figure 1). When entering it is relatively easy to see and avoid this but coming back out, it is impossible to see as it is under the pipes so there is a definite hazard in putting a foot or ankle at jeopardy.
- 3) Cutting and trip hazard due to cable tray extending out into passage way (Figure 2).

Figure 1 – Drainage Trench under Water Pipes in the Passage Way

- 1) Add more light.
- 2) Temporarily cover drainage trench with plywood.
- 3) Tag cable tray or remove.

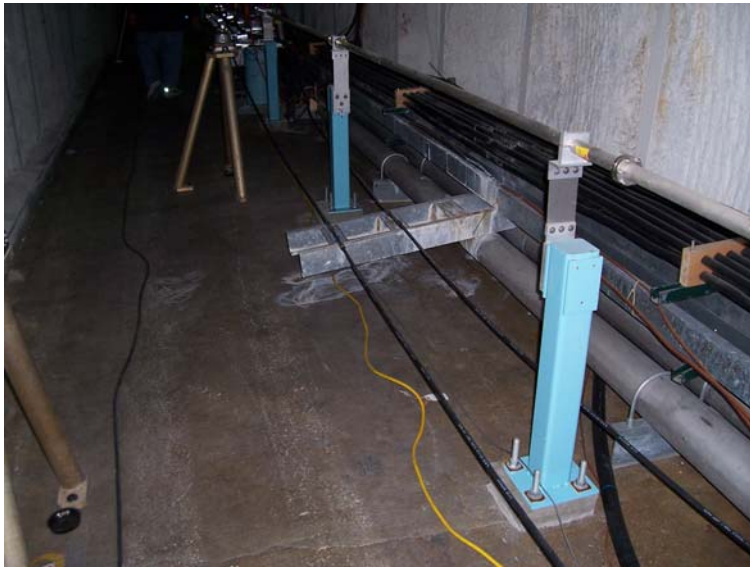
Figure 2 – Cable Tray Extending Into the Aisle

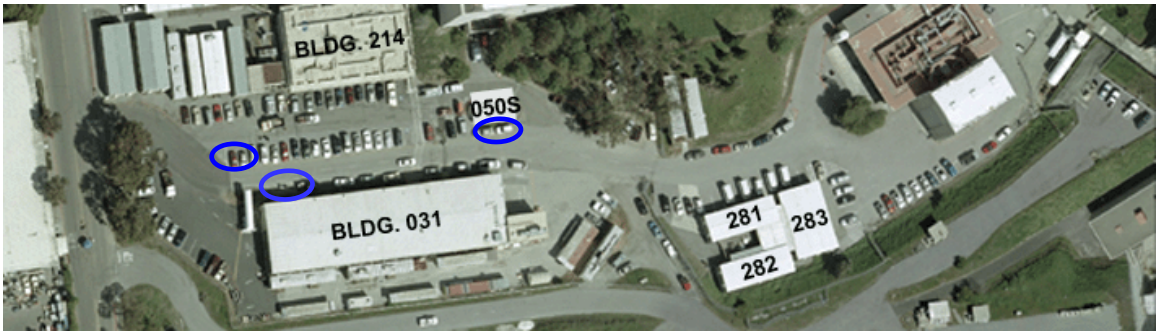
Hazards: Parking spots not clearly marked or located so that cars park too close to the roadway restricting the amount of space for passing (see Figure 3).

Figure 3 – Three Parking Areas That Should Either Be Removed, Changed or Have Better Markings,

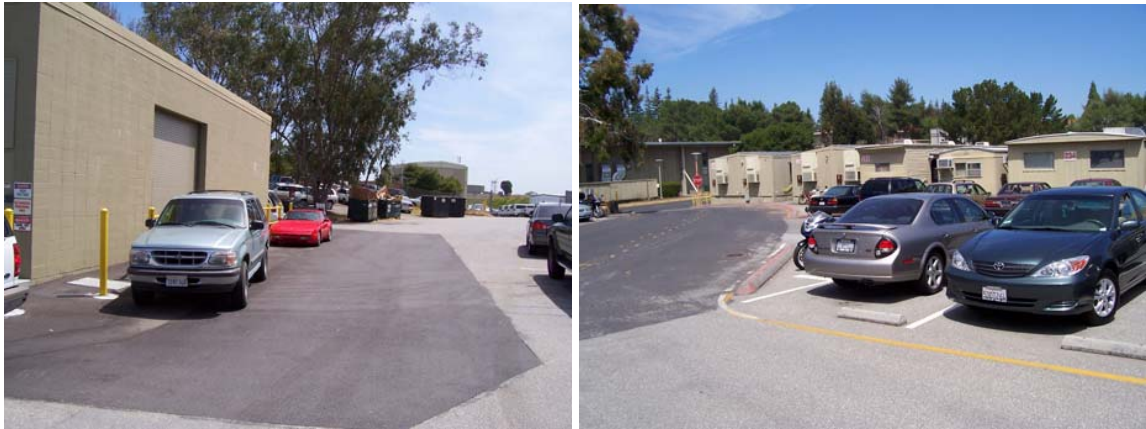
Figures 4 and 5 – These Spots Should Not Be For Parking (Left) and This One Parking Spot Should Have the Concrete Stopper Moved In From the Road a Foot or Two

Idea: 1) Two adjacent parking spots near the new utility building 050S (Figure 4) are of some concern. Vehicular traffic passing next to the building can be significantly restricted for room when passing, especially in the case large trucks and vans traveling through this area. Removal of these two parking spots with appropriate marking on the pavement is proposed.

Idea: 2) One parking spot at the curve in the road (Figure 5) should have the concrete barrier moved at least a foot or two north (away from the road) to prevent some cars from parking so far forward that their front end is significantly far out into the roadway.

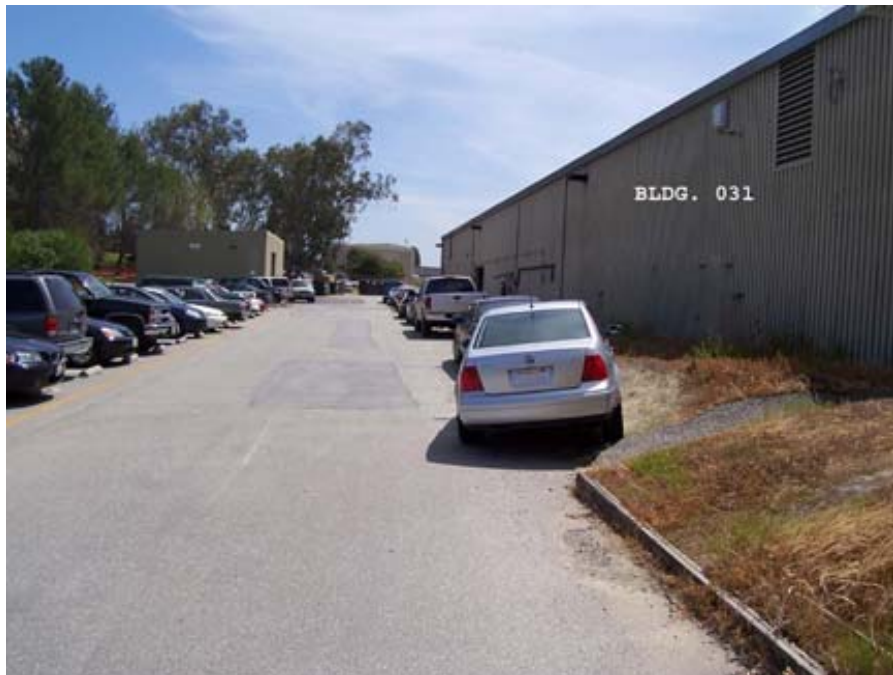
Figure 6 – This Parking Spot Should Be Better Marked So That Vehicles Do Not Park with the Tail-end Projecting Into the Roadway

Idea: 3) One parking spot next to the vacuum building (Figure 6) should be more clearly marked so that the driver knows not to leave the back end of their vehicle positioned so far out into the roadway.

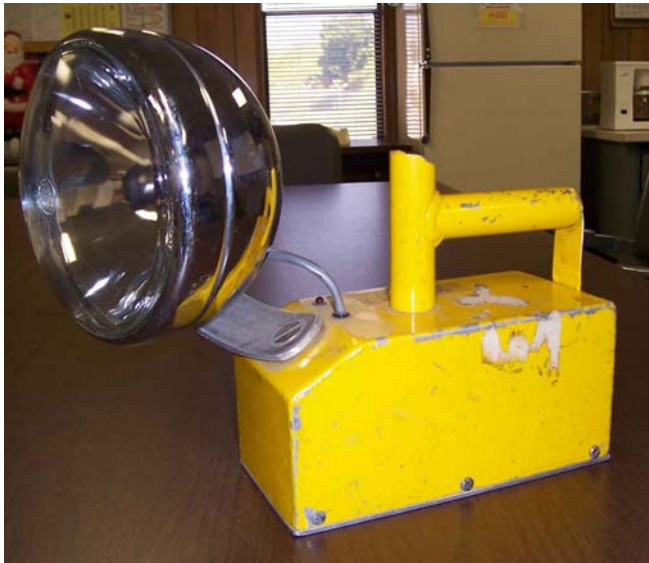
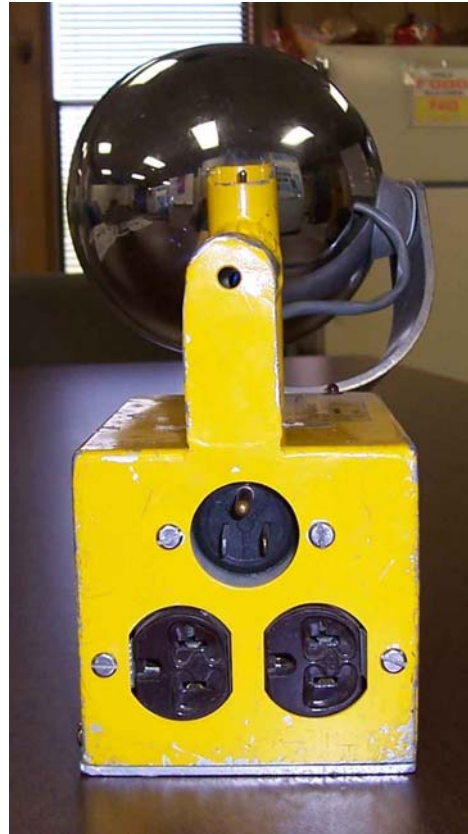
Hazards: Custom-made (Dozhier) light that has not been inspected by a nationally recognized testing laboratory. Item may shock, burn, or catch fire if not used properly.

Figures 7 and 8 – Custom-made Lights Need To Be Inspected and Possibly Replaced

- 1) Submit item to be inspected by SLAC Electrical Equipment Inspection Program.
- 2) Use a suitable replacement light that has already been inspected by a nationally recognized testing laboratory.
