## Breakdown Studies NLCTA

*Experimental Issues of High Power Operation*

*NLCTA – Marc Ross*

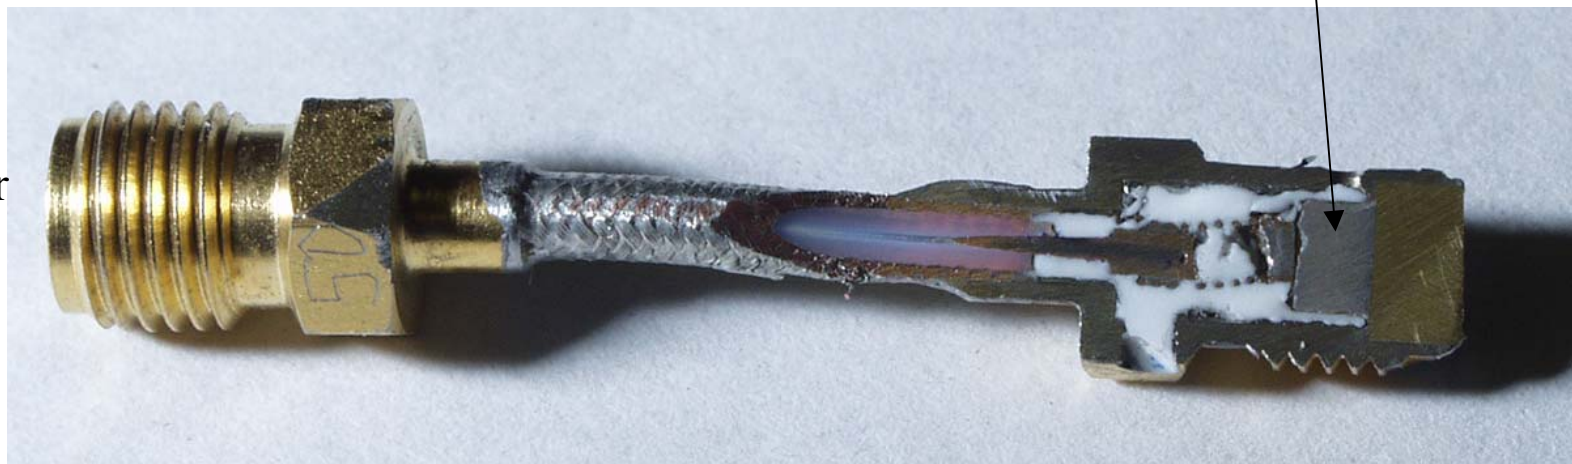
## Acoustic Emission Sensor:

100 KHz – 1 MHz (speed is 3 mm/us)

Non-directional

SLAC-built  
PZT piezo

SMA connector

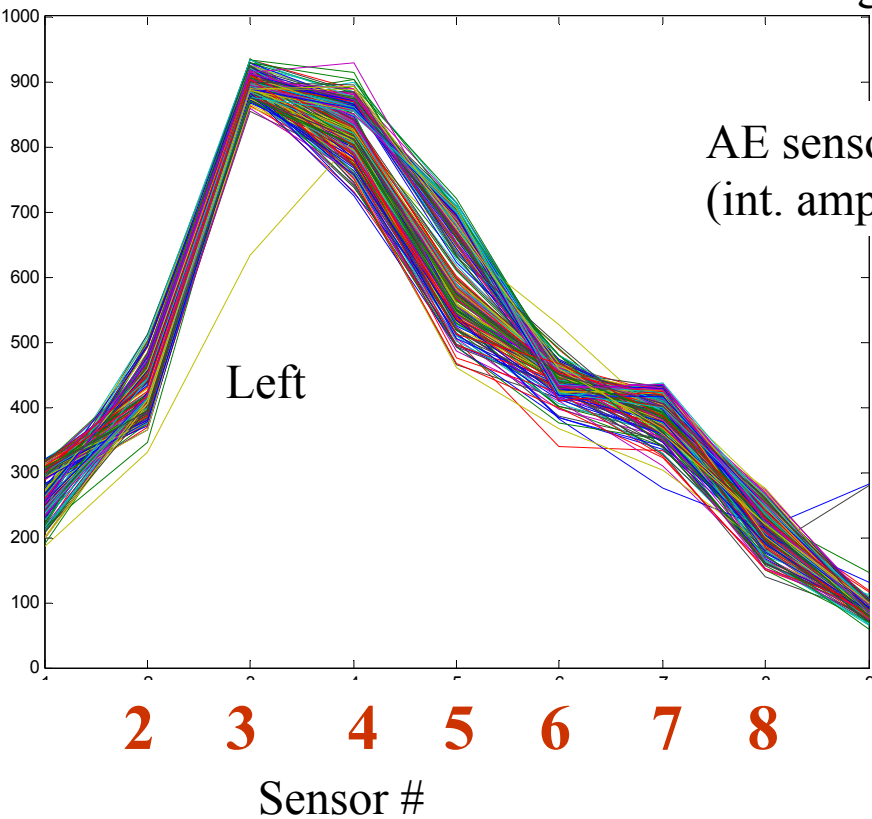
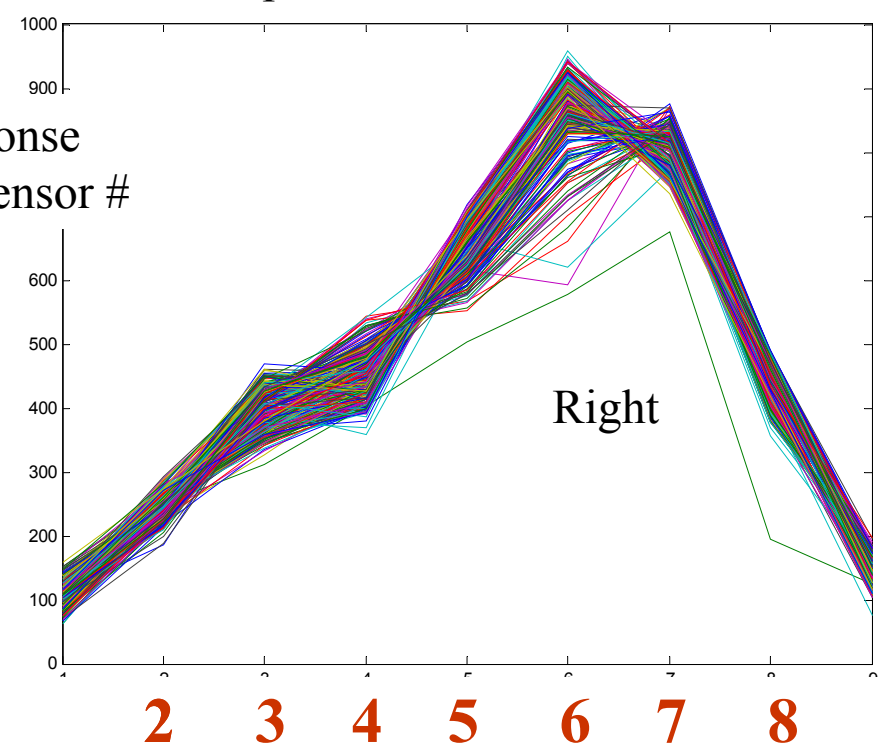
# Sensor signals from ~ 600 coupler breakdowns

All coupler breakdowns come from one side or the other

Data: 1/24-1/30  
830 bkdns  
289 R 259 L  
270 F  
(30 bulk RA)

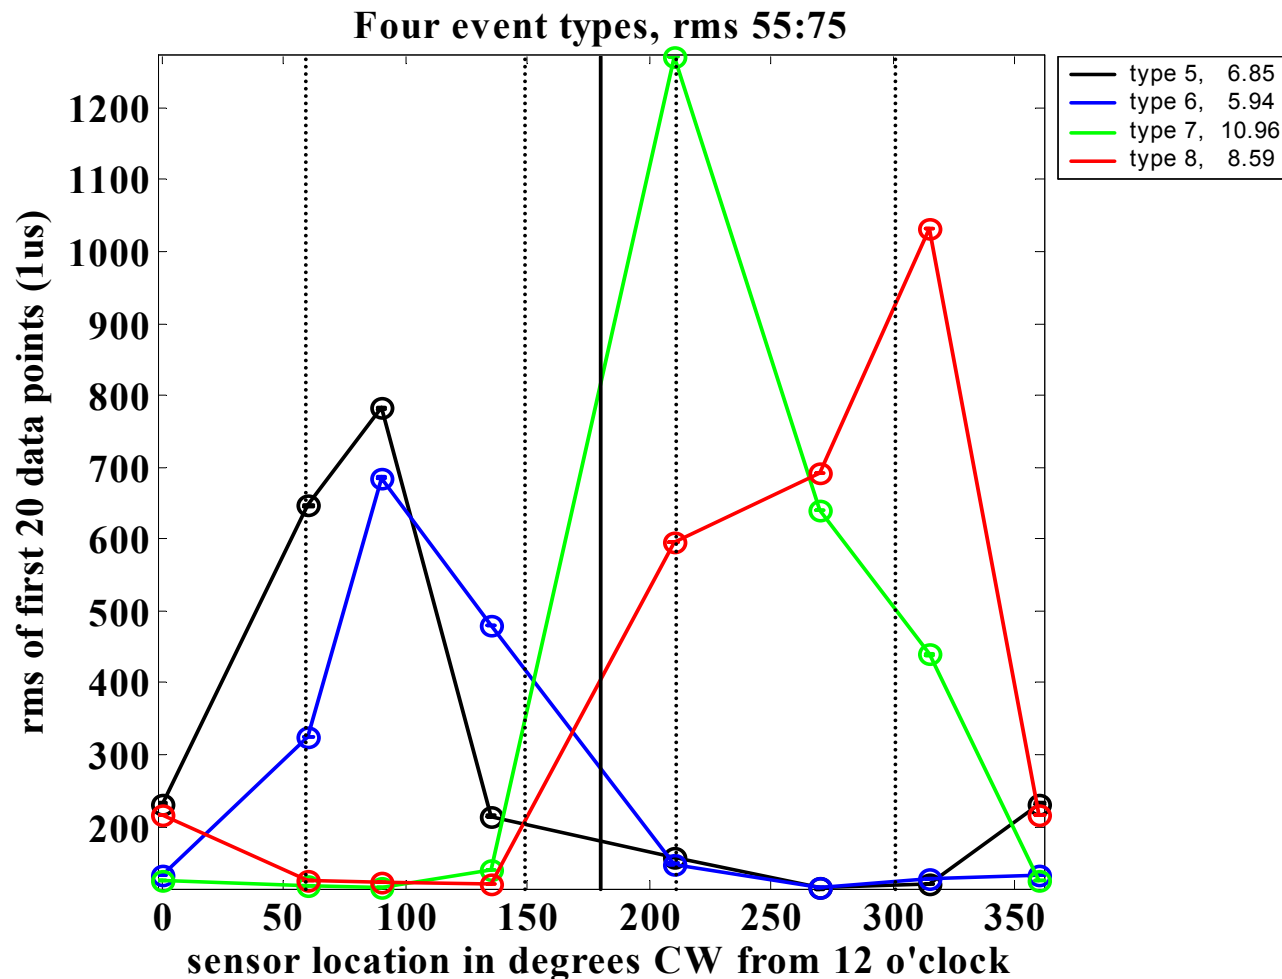
# Prompt acoustic signal

Showing breakdown signals from the 4 horns

First 10 us of the waveform  
(10 us ~ 30 mm)

Signal imbalance much larger than 3:1

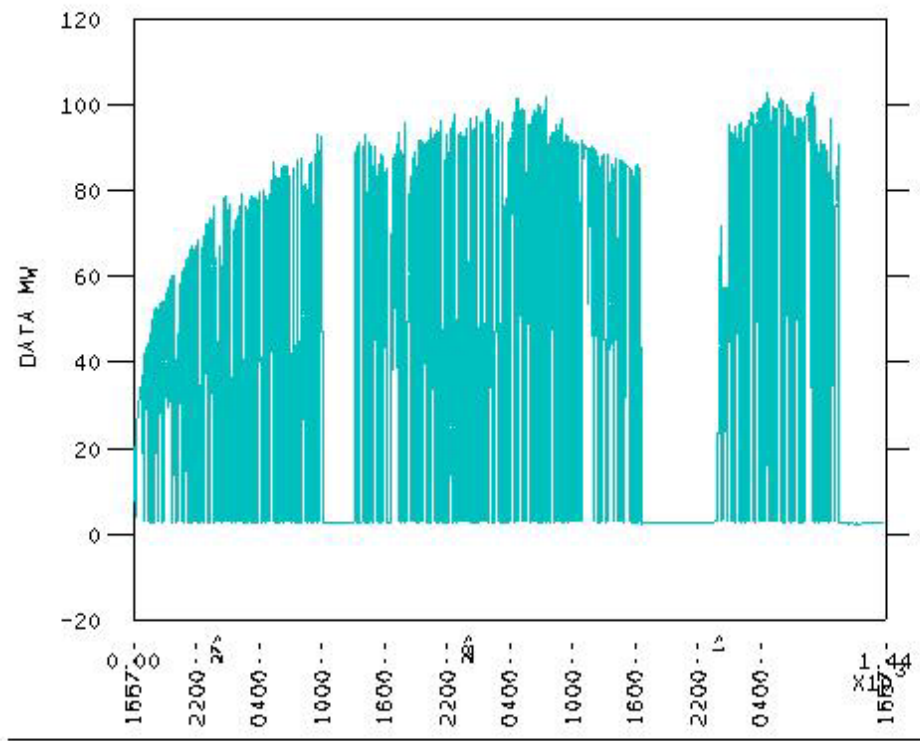
# 2 vents – 2 bakes – 2 recoveries

INTERVAL: 60 MEAN: 50.18027  
 SIGMA: 48.90501  
 LAST DATA POINT: 11-AUG-2001 15:54:41

MIN: .346561  
 MAX: 123.581  
 MAX-MIN: 123.234  
 3-MAY-02 16:07:01

INTERVAL: 60 MEAN: 40.16320  
 SIGMA: 39.96728  
 LAST DATA POINT: 1-MAR-2002 15:55:29

MIN: 1.97498  
 MAX: 102.828  
 MAX-MIN: 100.853  
 3-MAY-02 16:05:25

- What does conditioning/processing do to the copper?
- Important experiment done in March 2002
  - Clean (but very close) vent, followed by a bake
  - Bake was good but...
  - Re-processing was very slow
  - (in contradiction with earlier claims DDS2 etc @  $\sim 40\text{MeV/m}$ )
- Why?
- Look at studies done by CERN (Grobner) to prepare the LHC vacuum chamber internal copper liner
  - Secondary emission coeff. Processing ← what does this have to do with processing?
  - Gas monolayer processing
