GLAST Repeatability Results

Laser Tracker Study in SLAC
Building 33 - Room 104

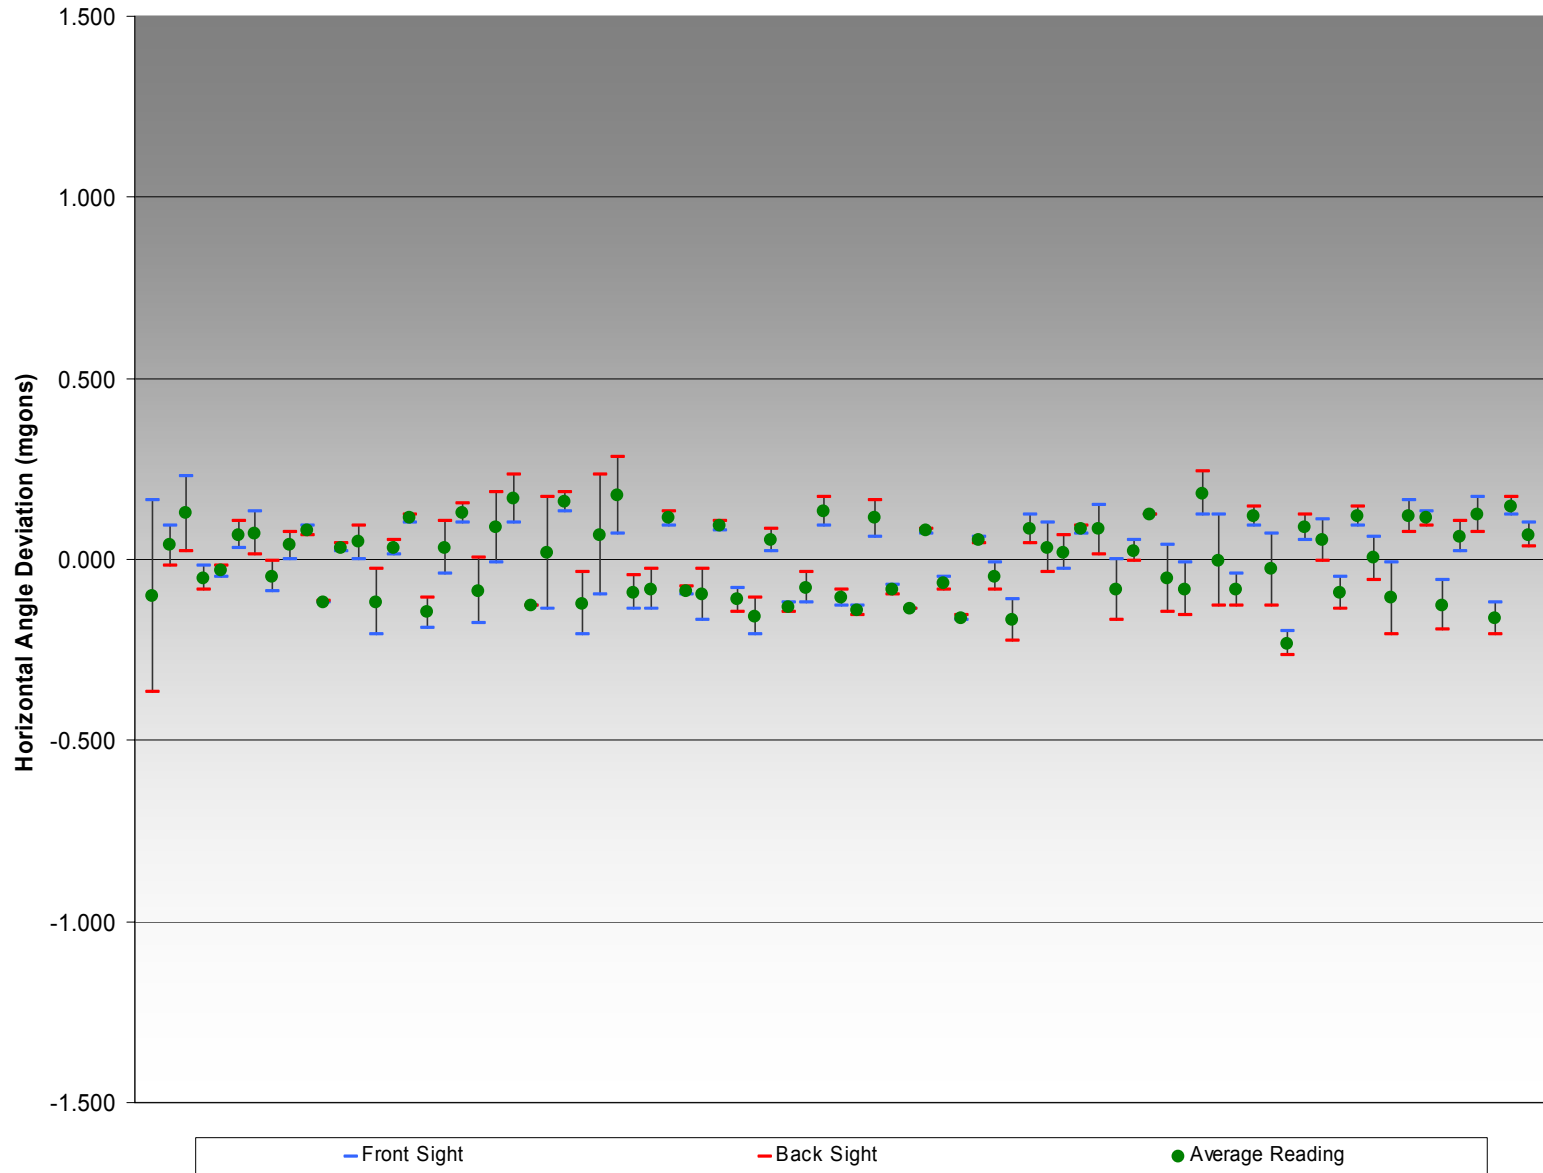
High Position Laser Tracker Repeatability Study Observing Target "Stand" Horizontal Angle Readings

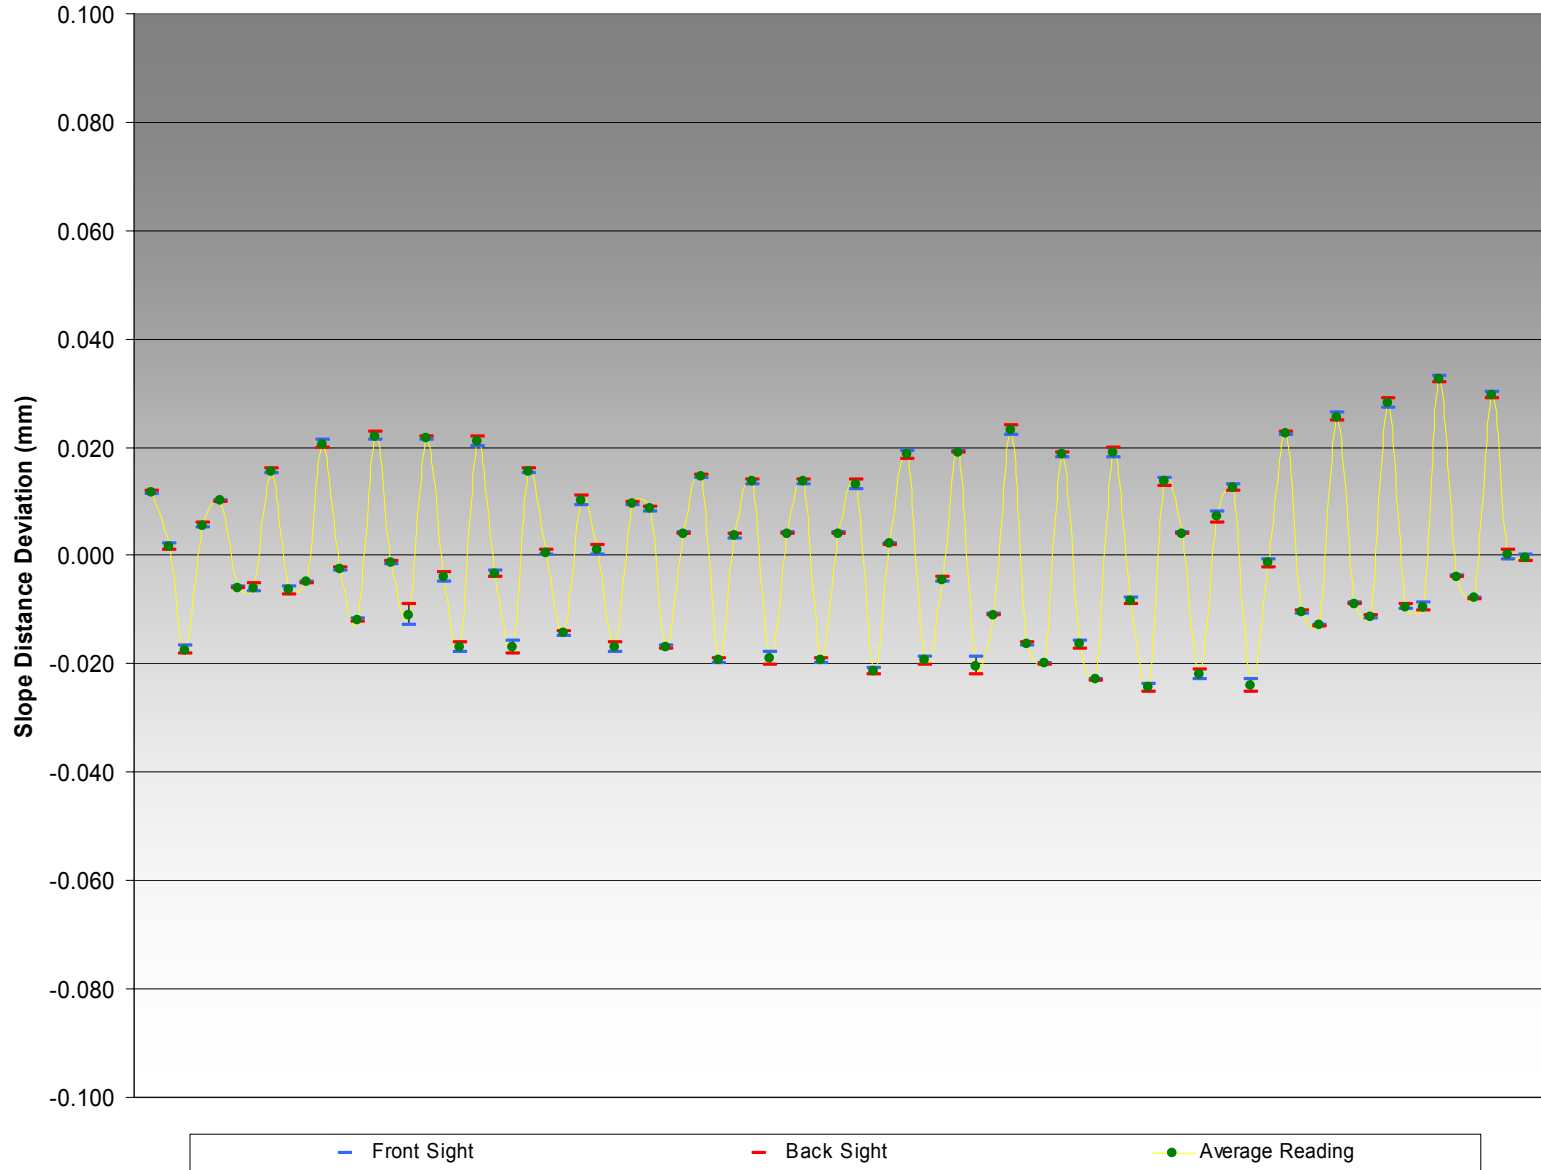
High Position Laser Tracker Repeatability Study Observing Target "Stand" Slope Distance Readings

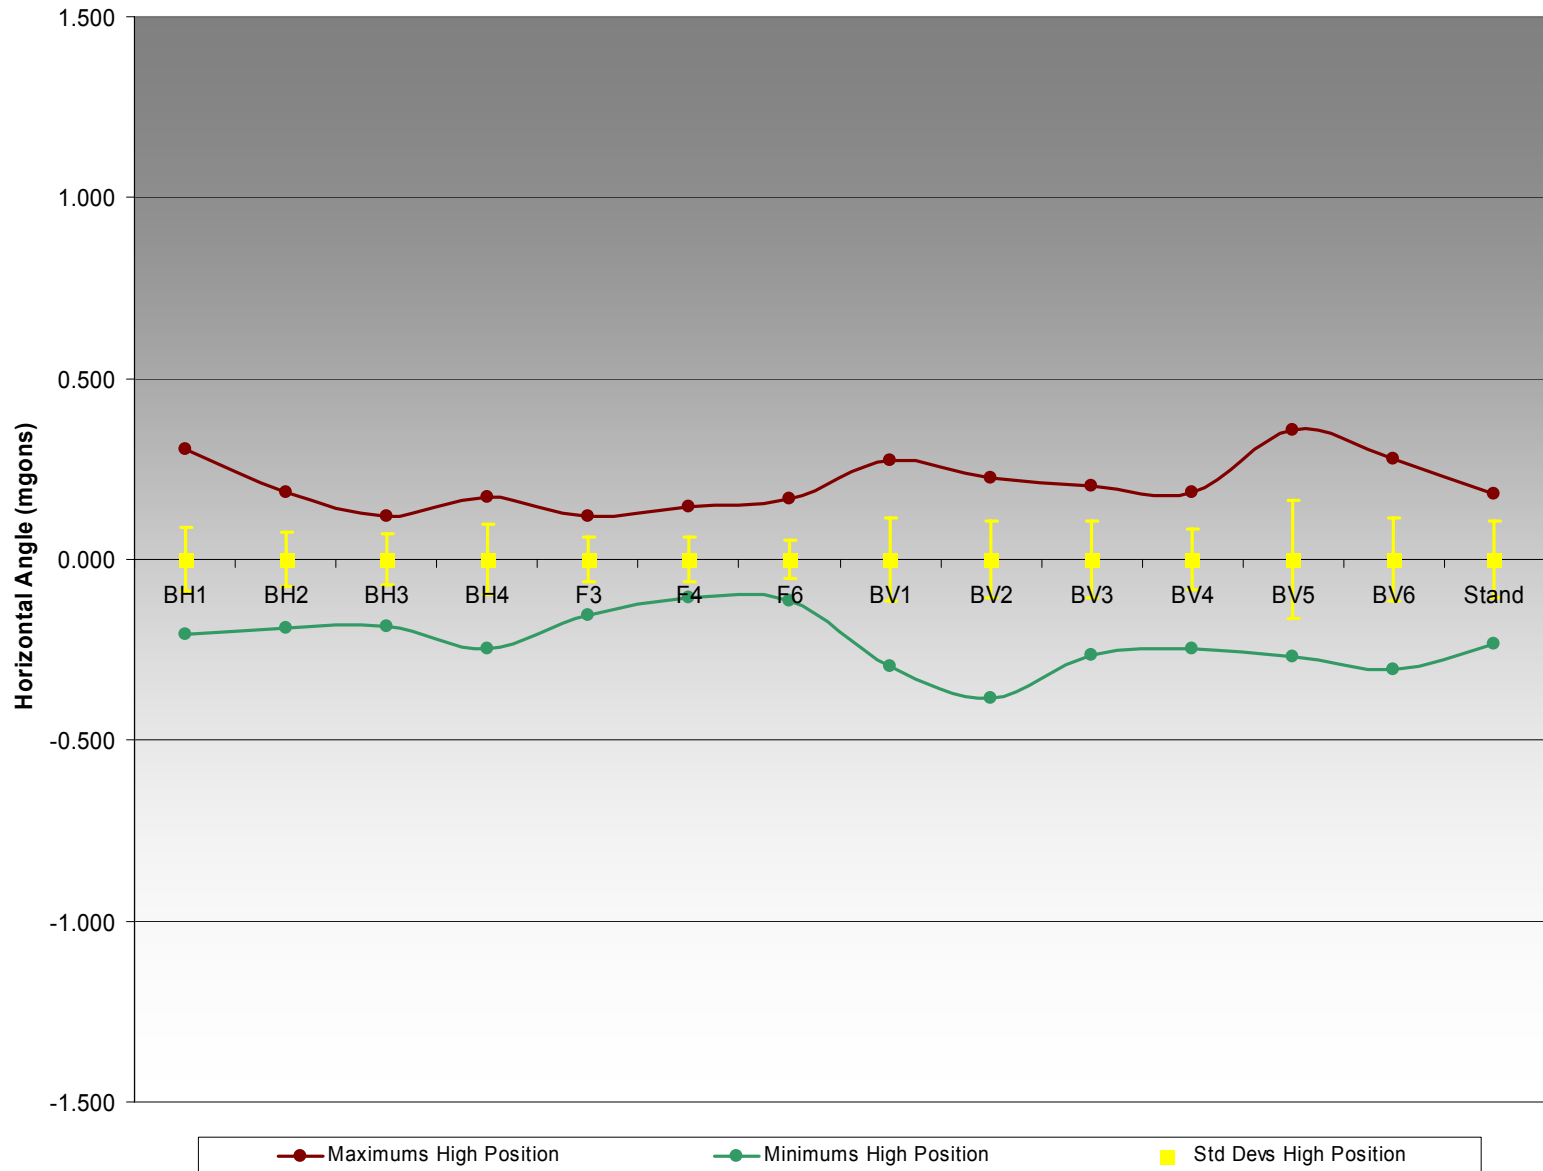
High Position Laser Tracker Repeatability Study Horizontal Angle Readings

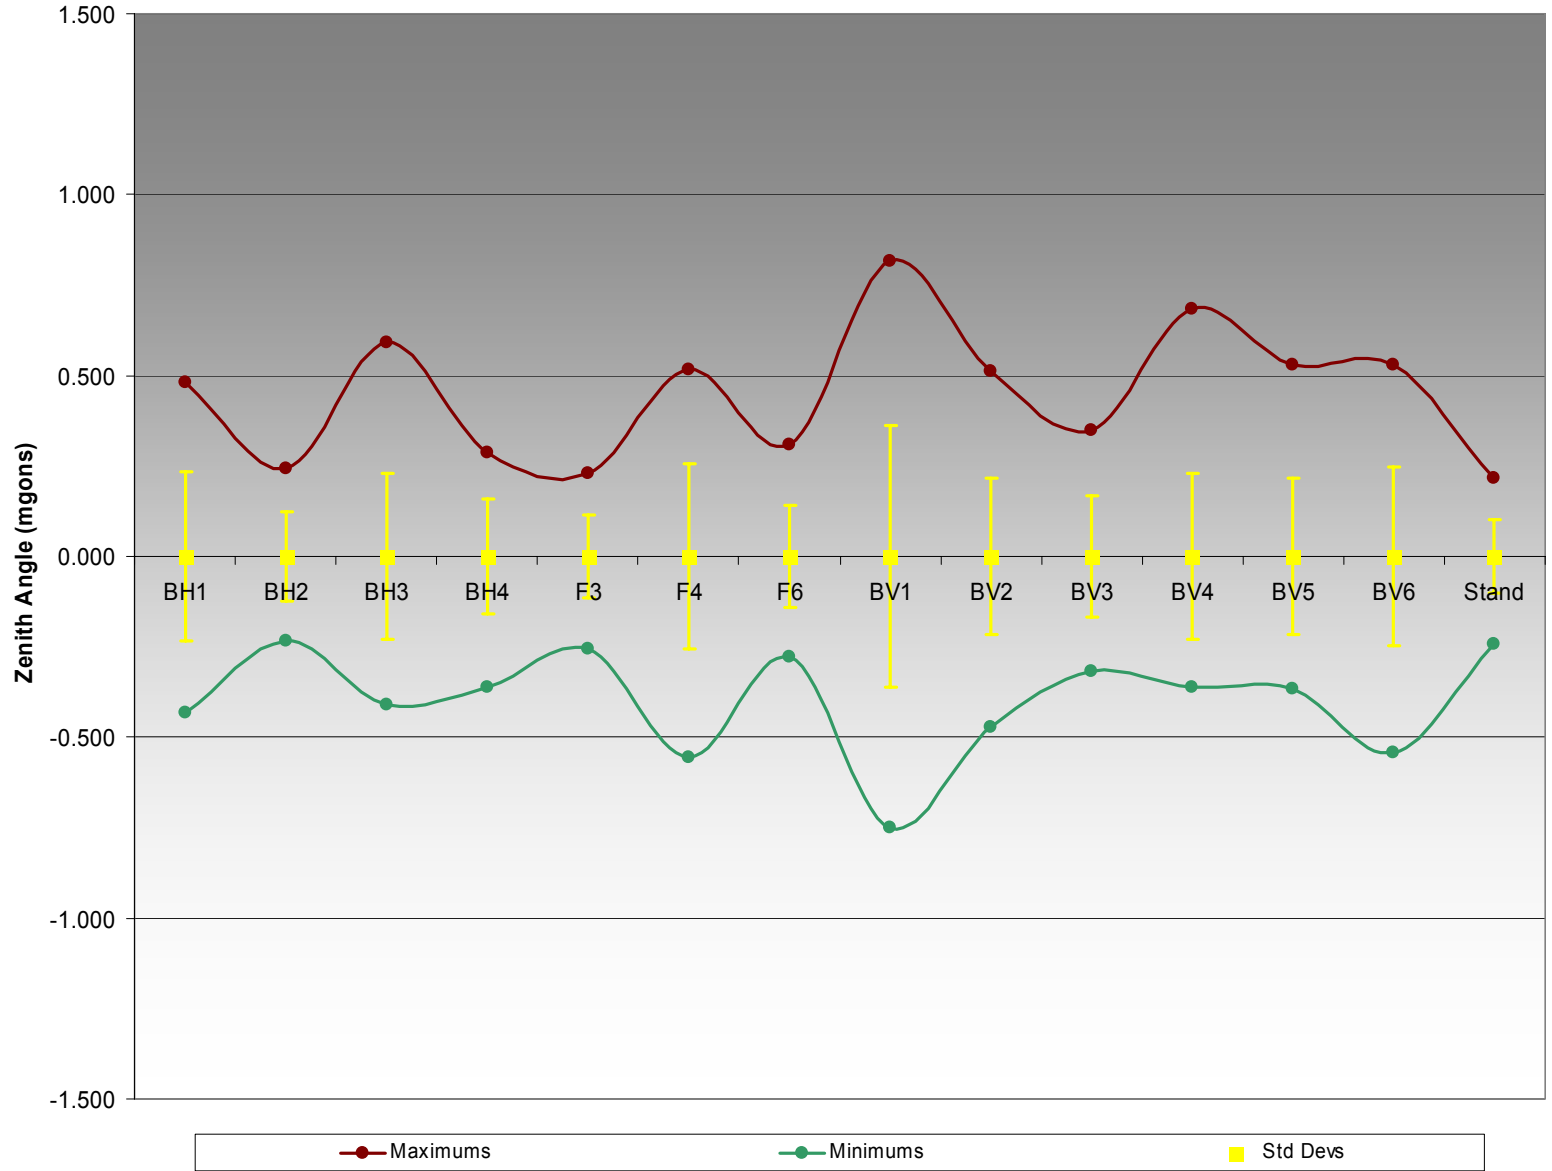
High Position Laser Tracker Repeatability Study Zenith Angle Readings

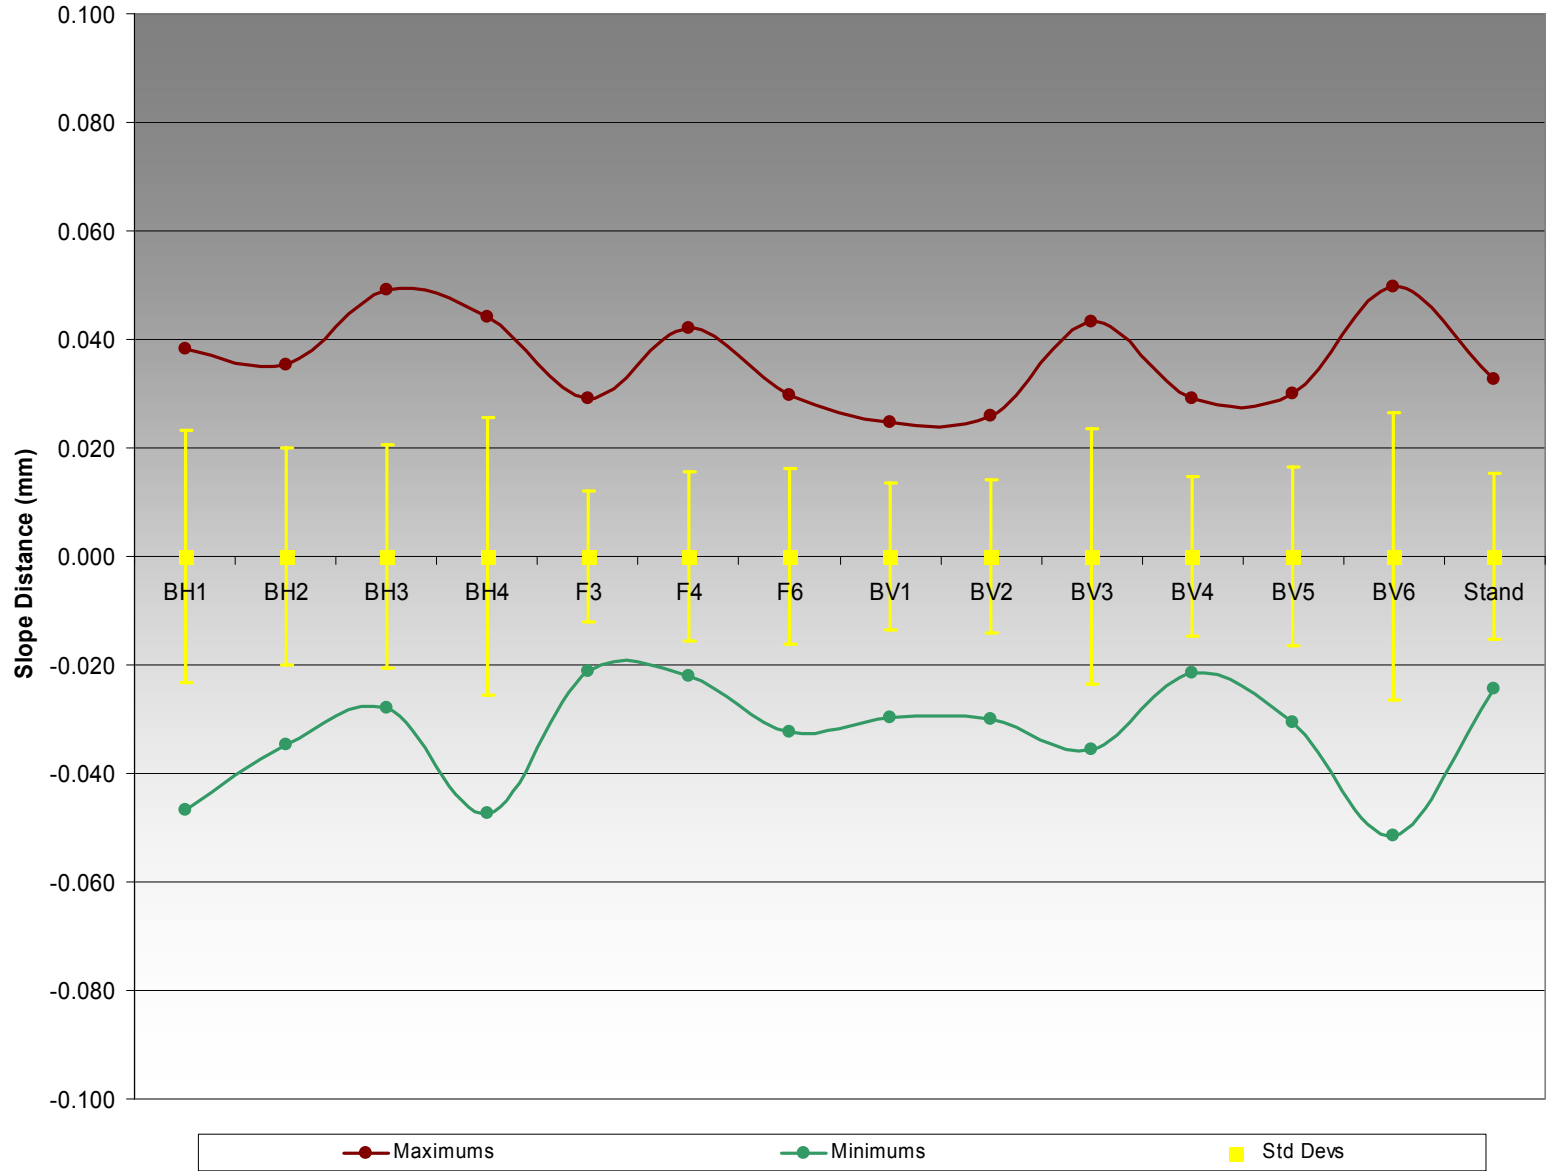
High Position Laser Tracker Repeatability Study Slope Distance Readings

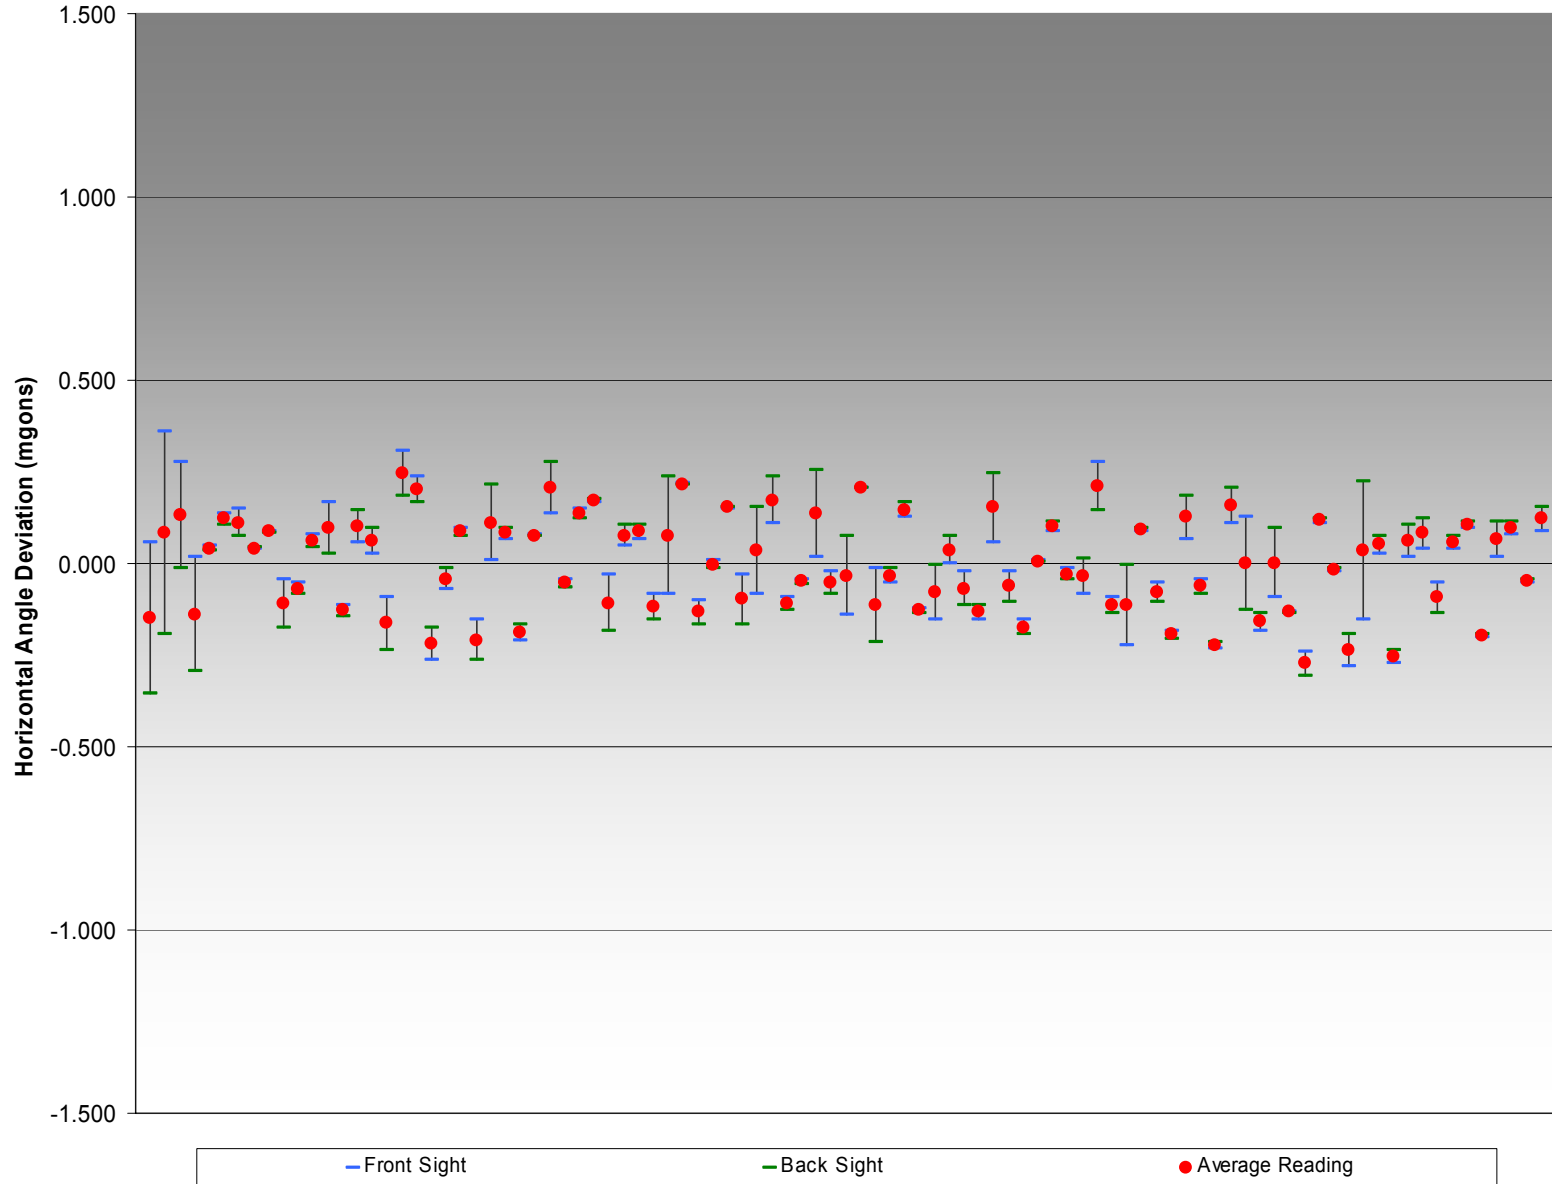
Low Position Laser Tracker Repeatability Study Observing Target "Stand" Horizontal Angle Readings

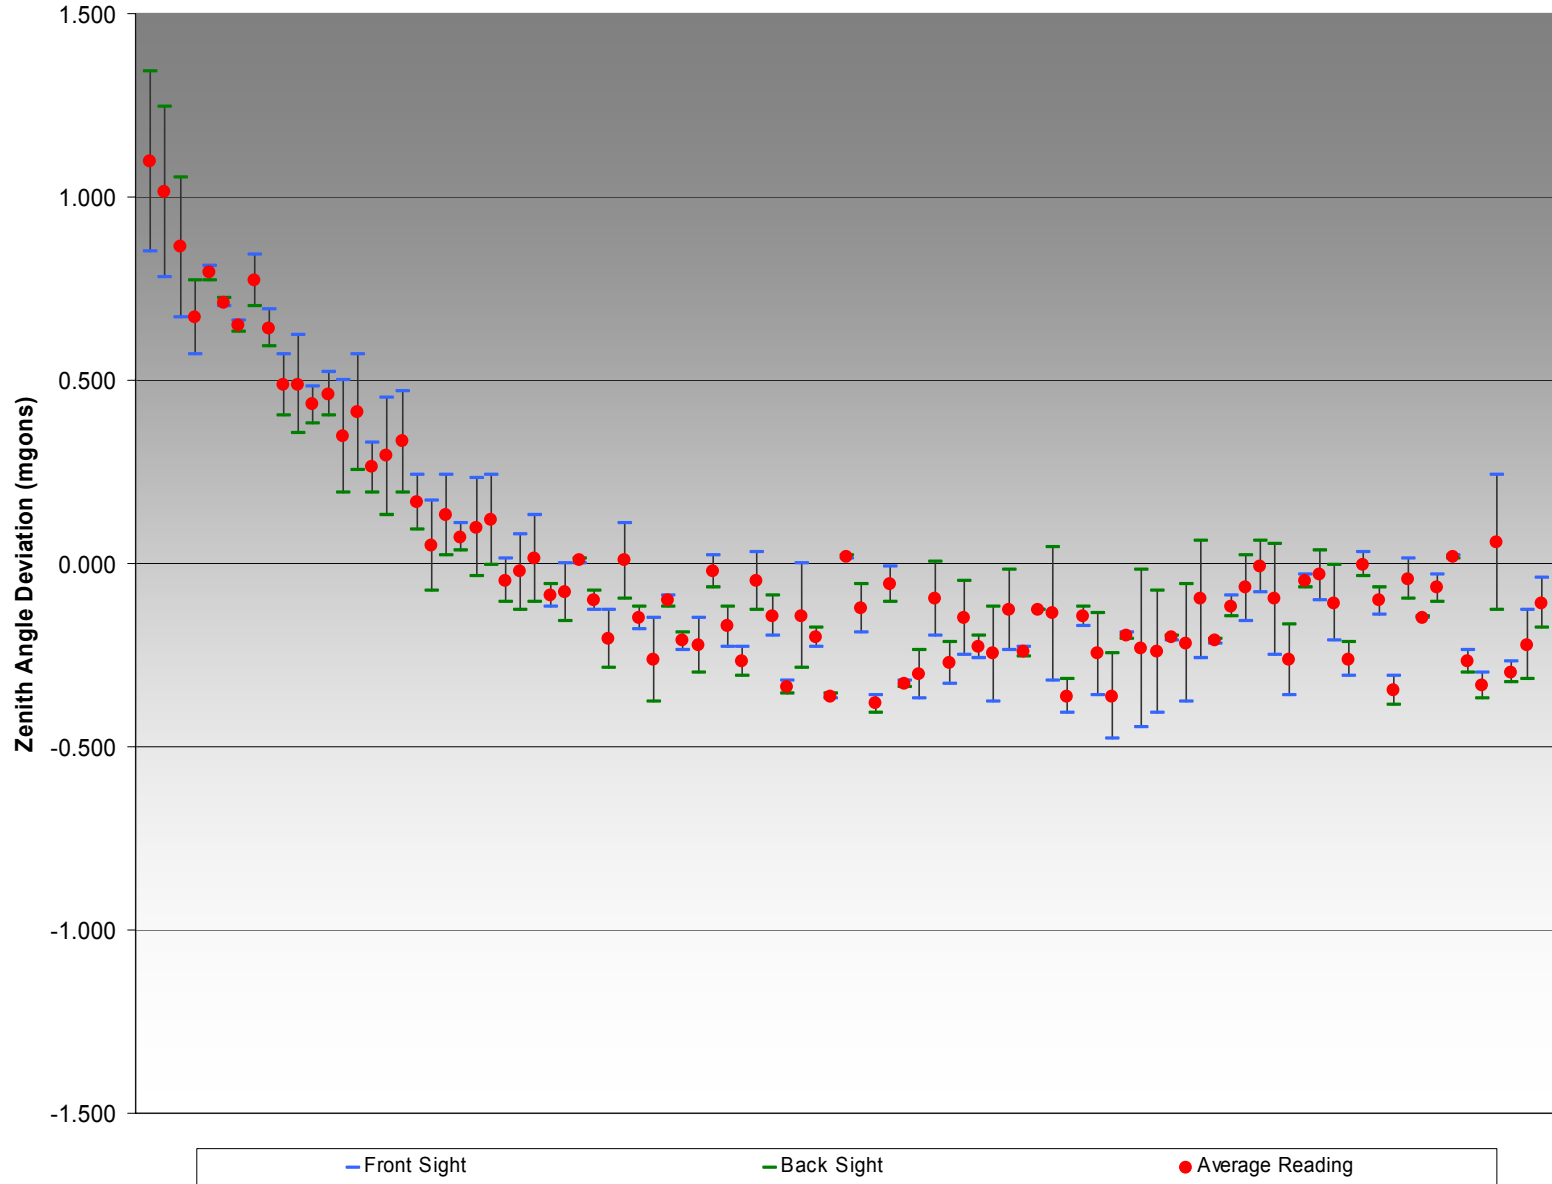
Low Position Laser Tracker Repeatability Study Observing Target "Stand" Zenith Angle Readings

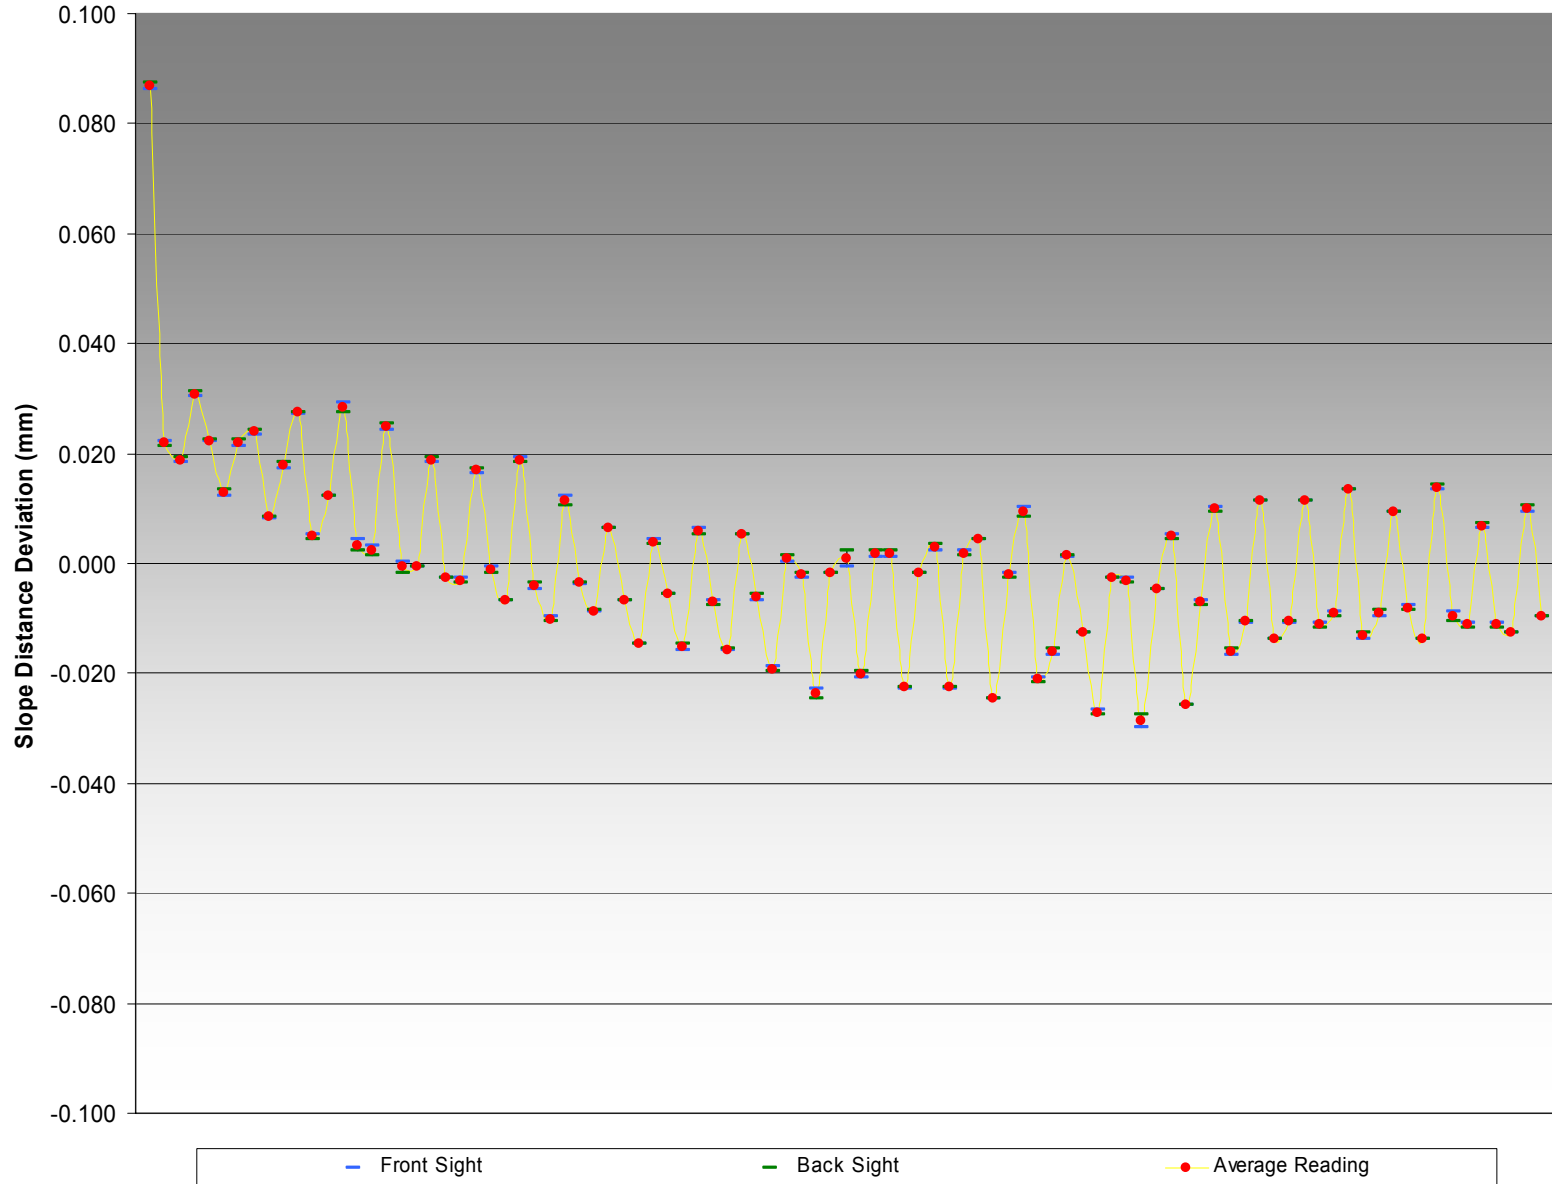
Low Position Laser Tracker Repeatability Study Observing Target "Stand" Slope Distance Readings

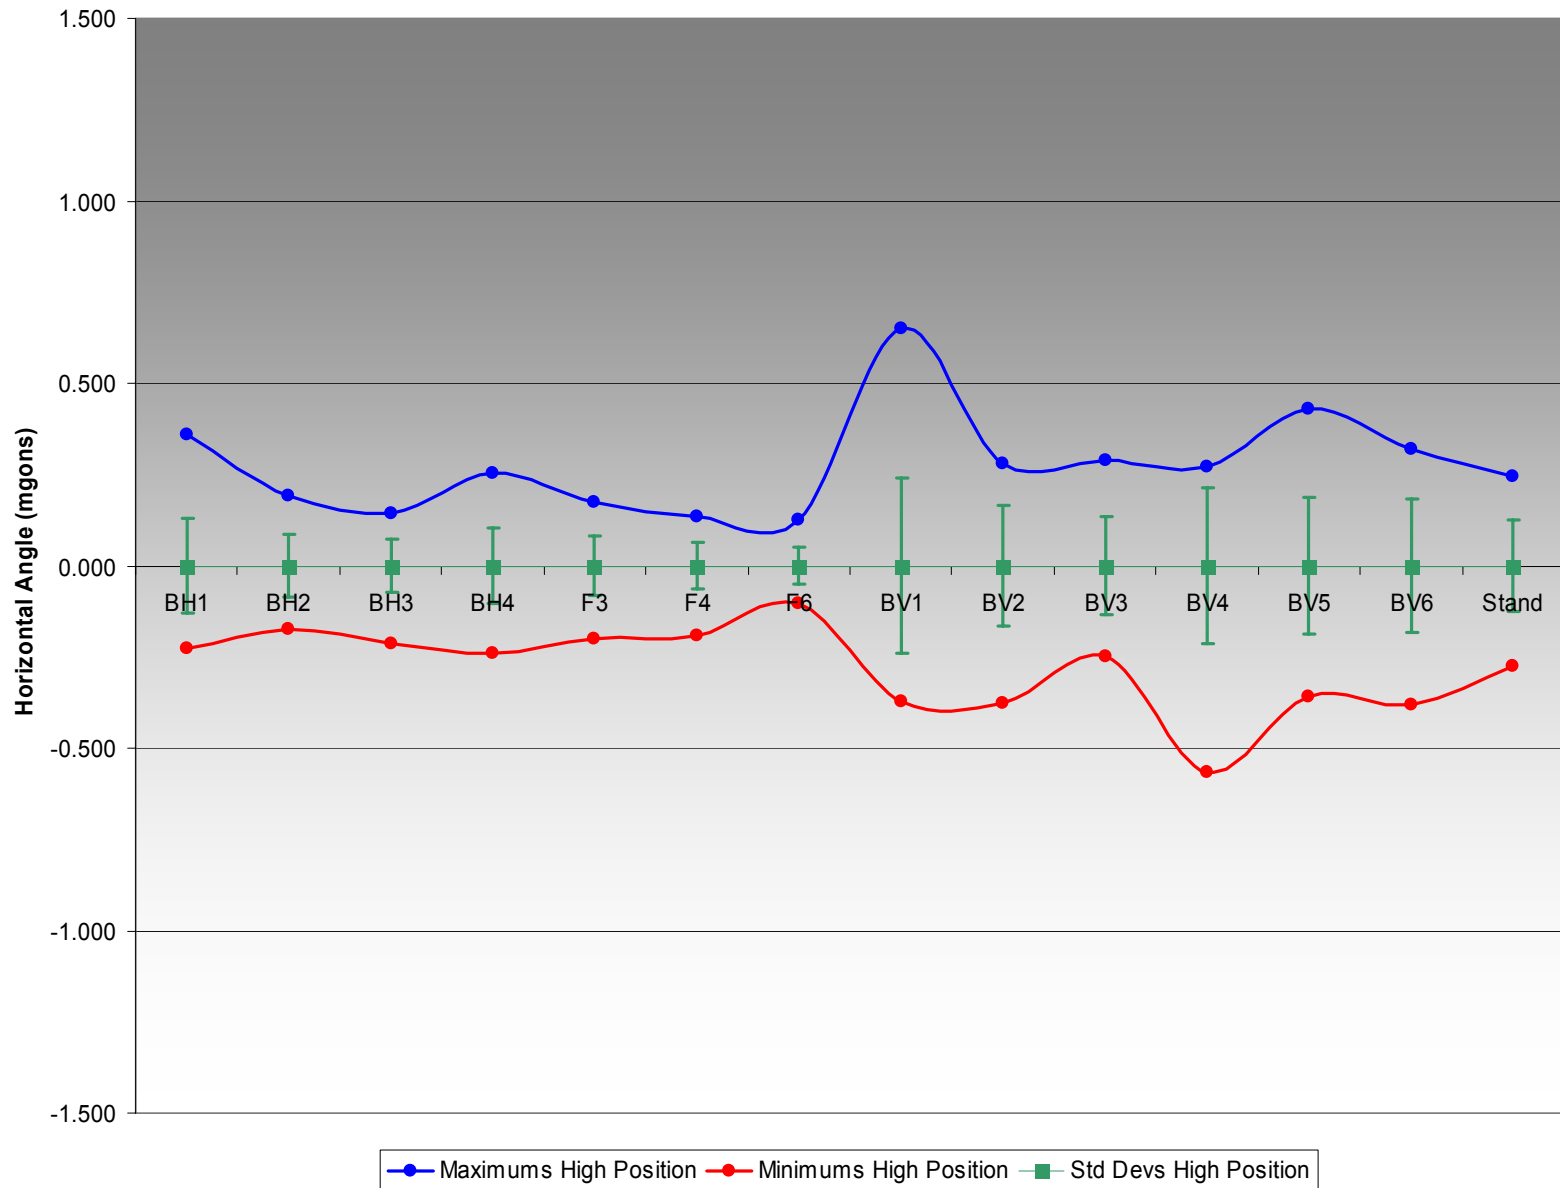
Low Position Laser Tracker Repeatability Study Horizontal Angle Readings

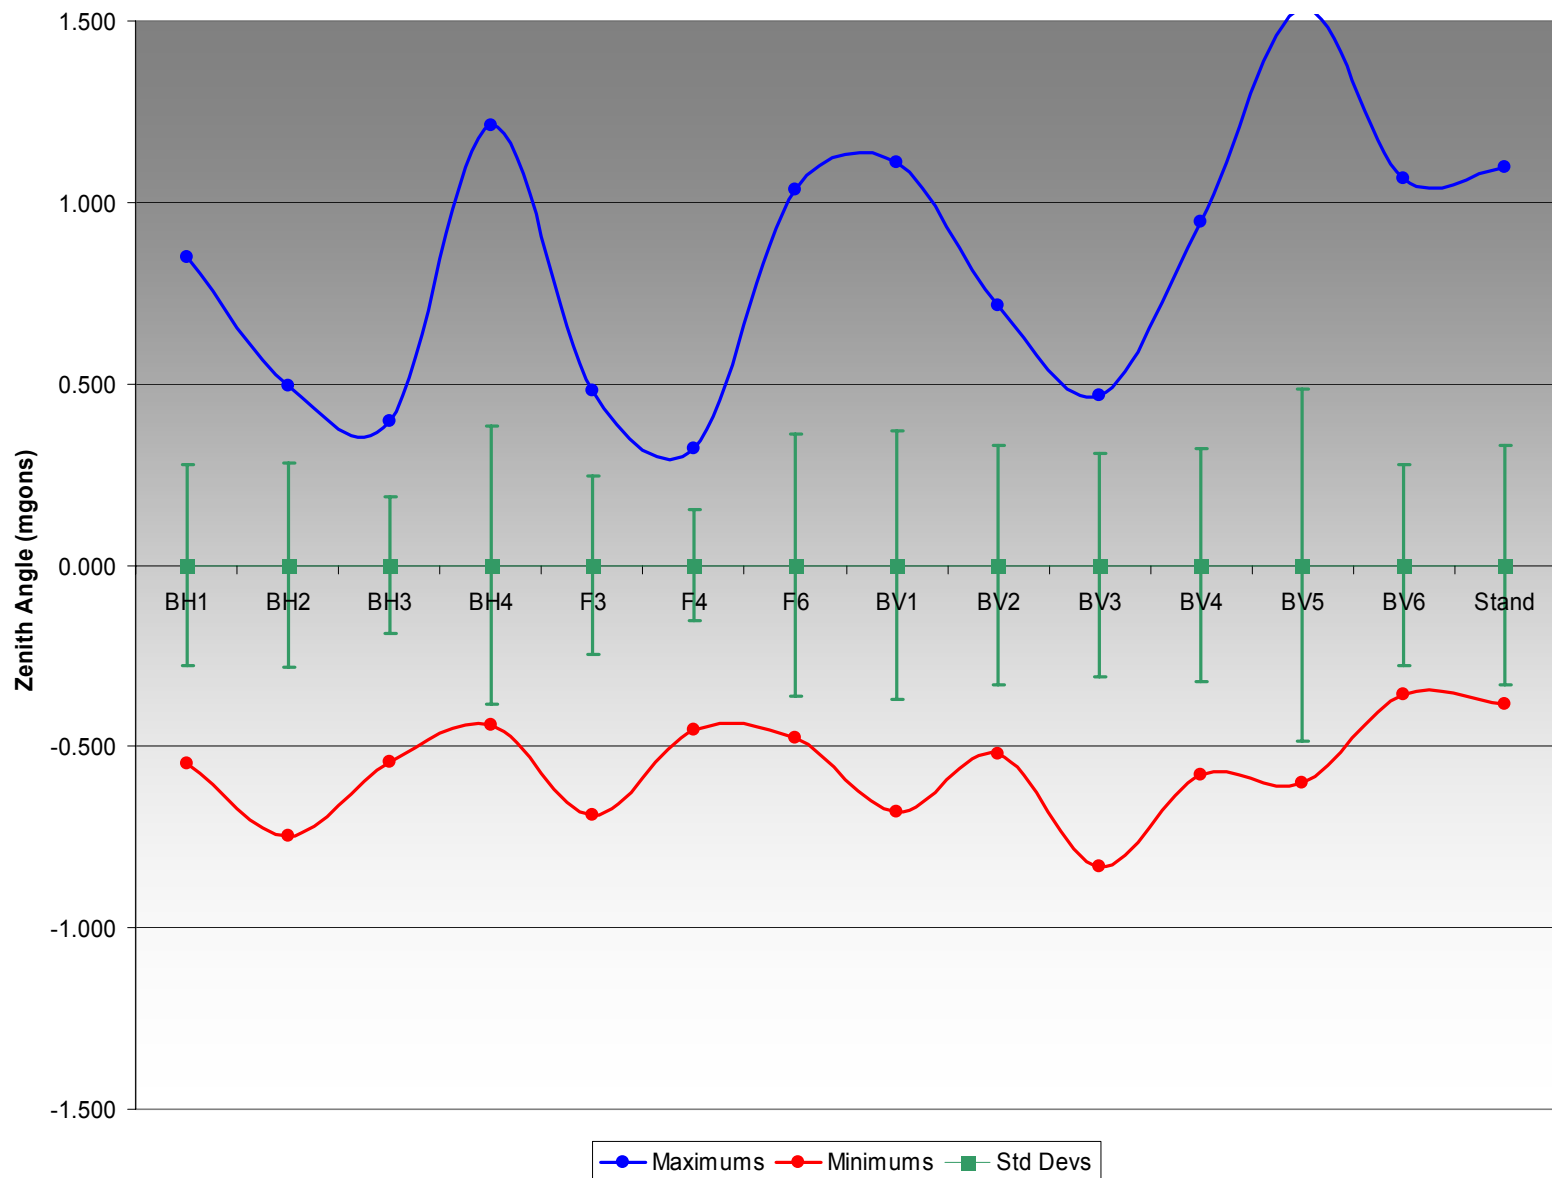
Low Position Laser Tracker Repeatability Study Zenith Angle Readings

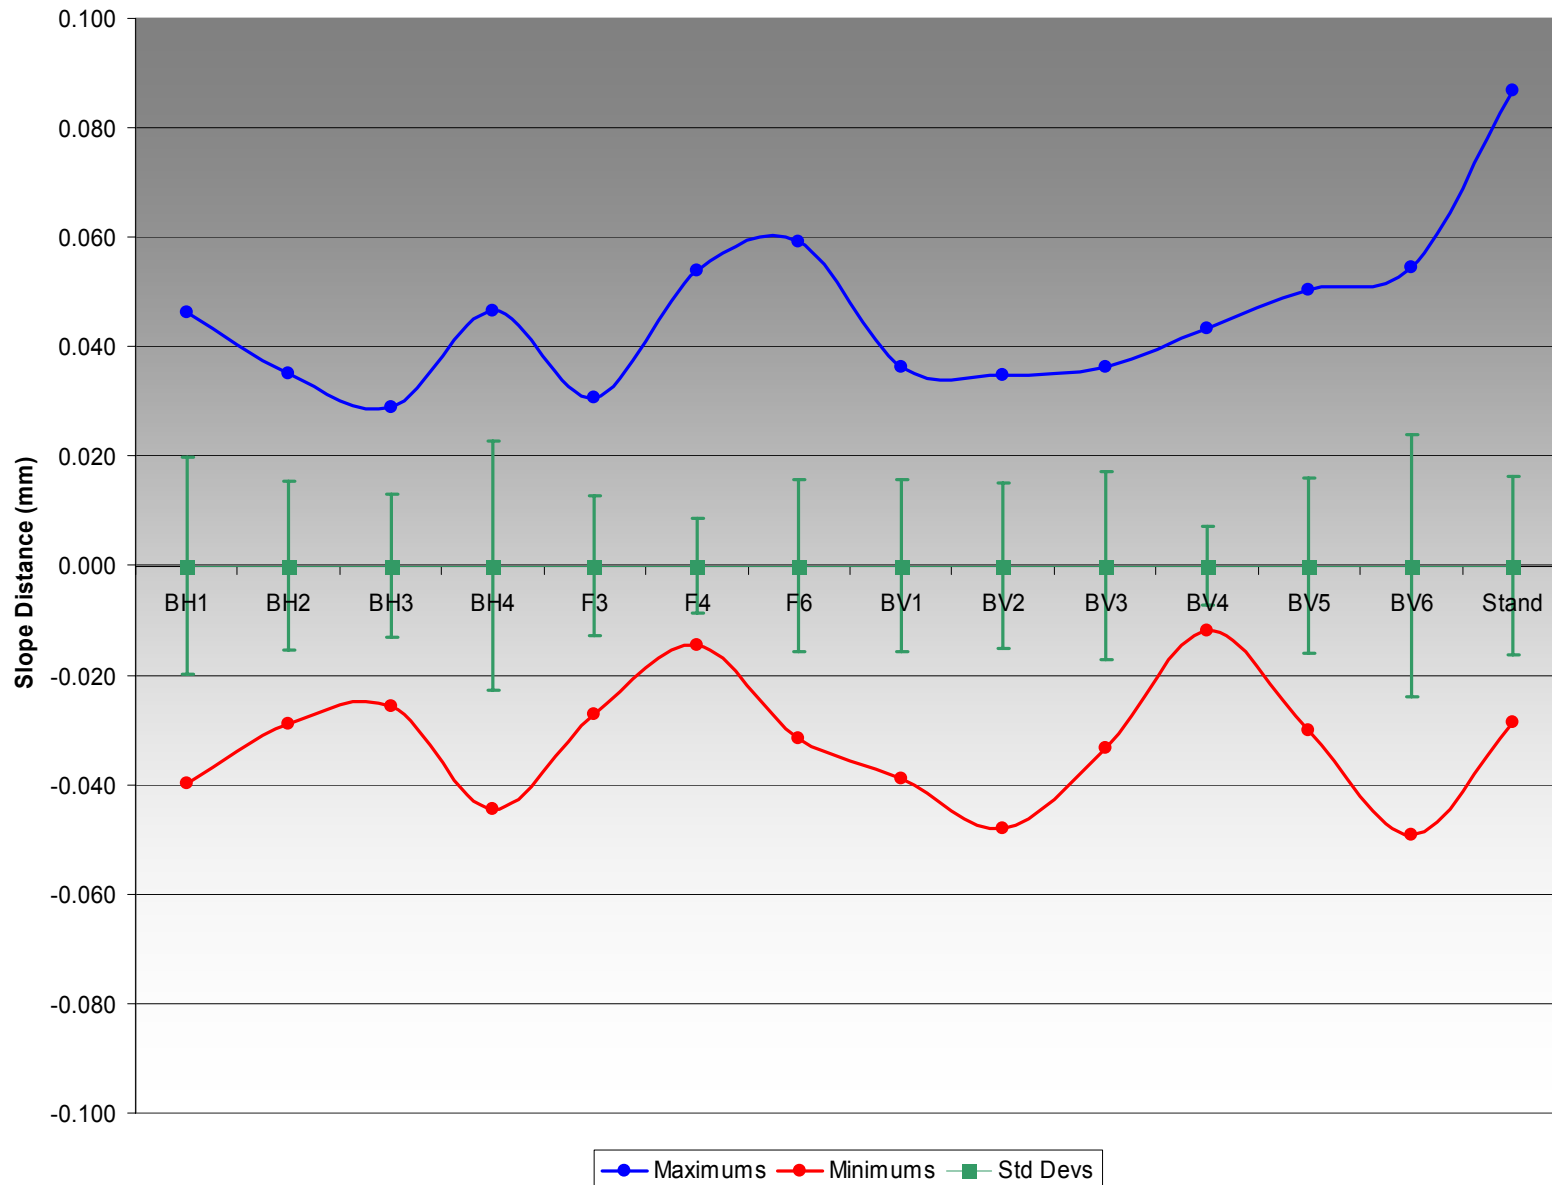
Low Position Laser Tracker Repeatability Study Slope Distance Readings

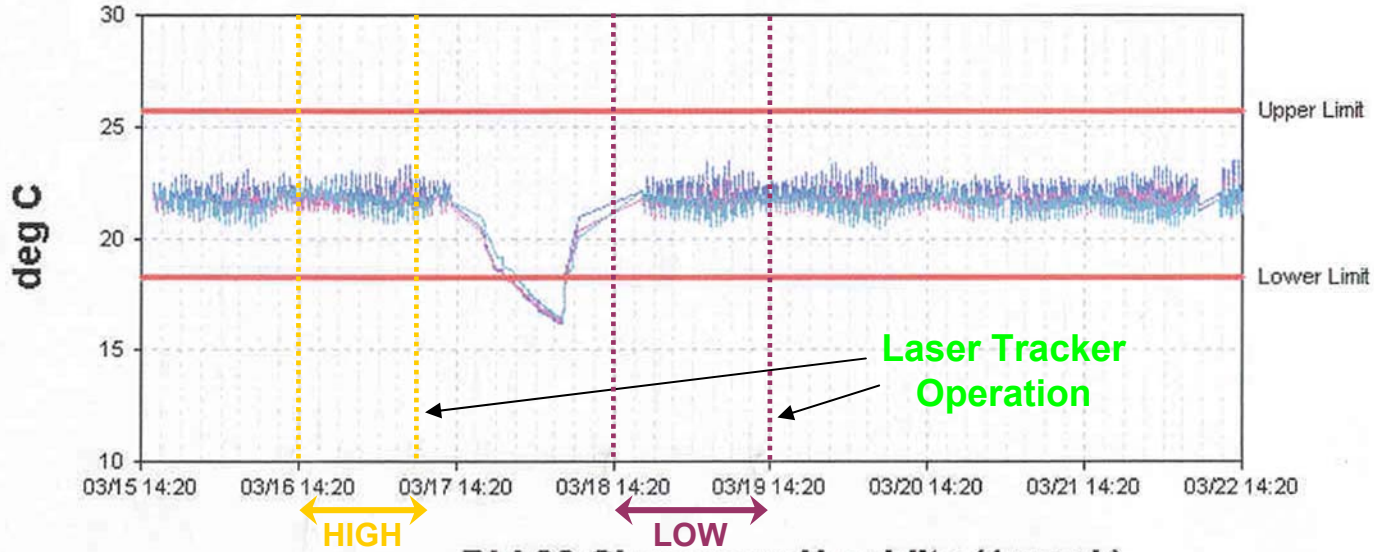
Bld 33 Cleanroom Temperature (1-week)

Top Plots

- TEMP-01
- TEMP-02
- TEMP-05

Time: 03/15/04 14:20:55 to 03/22/04 14:20:55, Duration: 7 days + 00:00:00

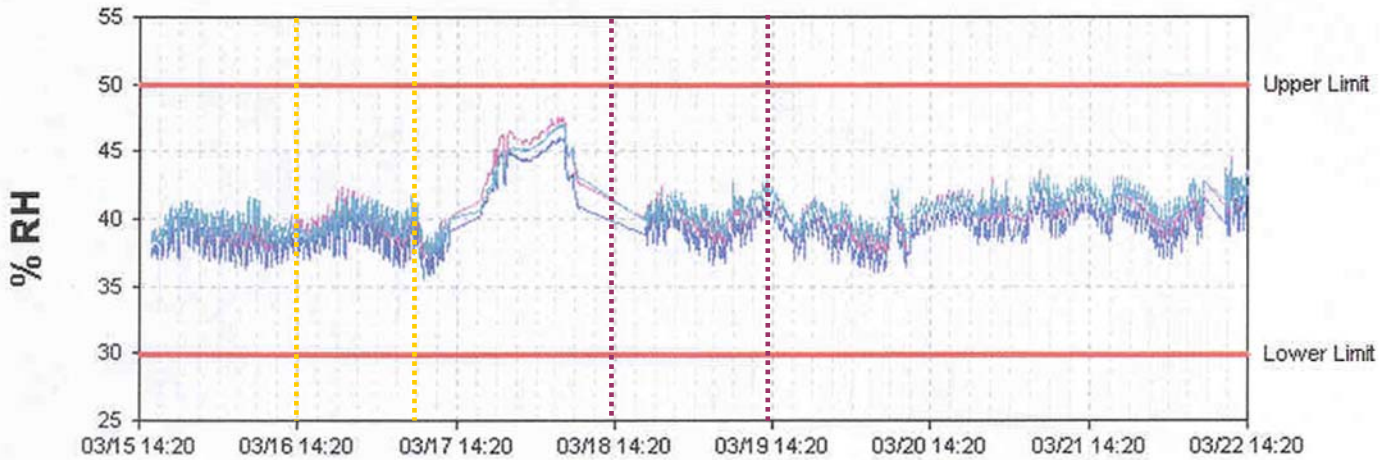
Bld 33 Cleanroom Humidity (1-week)

Bottom Plots

- HUM-01
- HUM-02
- HUM-05
